Pilot/Race 177, *The Galloping Ghost*
North American P-51D, N79111
Reno, Nevada
September 16, 2011

NTSB/AAB-12/01
PB2012-102899

Aircraft Accident Brief

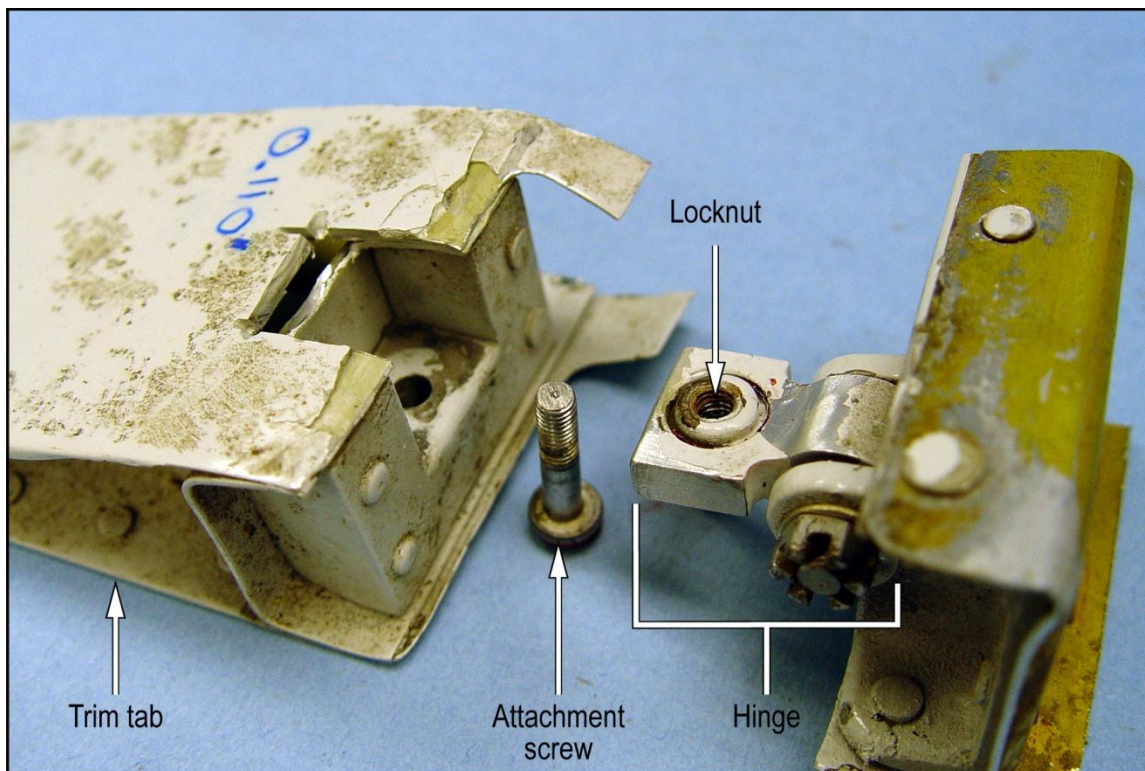
Each elevator trim tab is attached to three hinges on the elevator, with one screw per hinge (see figure 13). Examination of the left elevator trim tab pieces and the right elevator trim tab revealed that each had two intact screws (the center and outboard screws for the left tab, and the inboard and outboard screws for the right tab).

Figure 13. Section of right elevator trim tab (view of underside) showing the inboard hinge, attachment screw, and locknut.

All of the intact elevator trim tab attachment screws were loose with negligible resistance from their respective locknuts. The locknuts showed evidence of yellow paint beneath the uppermost coat of paint; records show that the airplane had been painted yellow before the 1985 NCAR. For each intact screw, the fiber locknut insert material applied little to no clamping pressure on the screw threads, and all of the inserts showed evidence of age and reuse³⁷ (see figure 14). The mating surfaces between each trim tab and its respective outboard, center, and inboard hinges displayed varying degrees of missing paint and exposure of bare metal, consistent with relative motion due to the loose screws. The left trim tab's outboard trim tab screw was slightly shorter than specified, and the center trim tab screw was significantly shorter than specified and its tail was flush with the end of the locknut.
