In-flight Fire, Emergency Descent
and Crash in a Residential Area
Cessna 310R, N501N
Sanford, Florida
July 10, 2007

Aircraft Accident Summary Report

NTSB/AAR-09/01/SUM
PB2009-910401

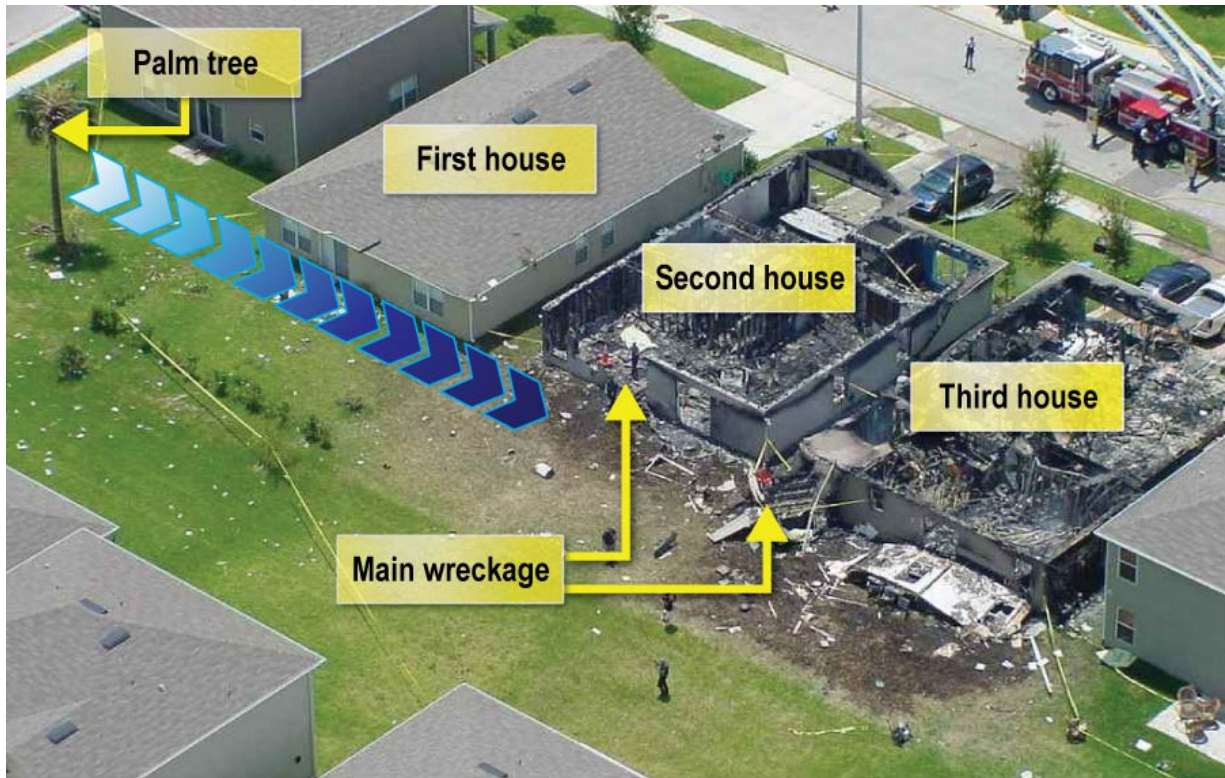
Airplane debris was found along the wreckage path, beginning near the impacted north-south line of trees and continuing to the impacted houses. (See figures 1 and 2.) The instrument panel glare shield⁶ was located on the roof of the first house. Most of the fuselage, the wings, the instrument panel, some avionics, seats, and the right engine were found in and around the second- and third-impacted homes.

Figure 1. Aerial photograph of main wreckage and impacted homes. The blue arrows show the general westerly direction of the airplane's travel at impact.

Further, the cabin door was found about 60 feet away from the main wreckage, as illustrated in figure 1, unburned and with latching pins undamaged. However, numerous soot deposits were noted on the interior side of this door, again consistent with an in-flight fire. These soot deposits trailed across the lower portion of the door from an area that would have been near the lower edge of the instrument panel on the intact airplane to the aft edge of the door. The undamaged latching pins and the location and existence of the observed trailing soot deposit are consistent with the pilots having opened the cabin door to vent smoke during an in-flight fire.

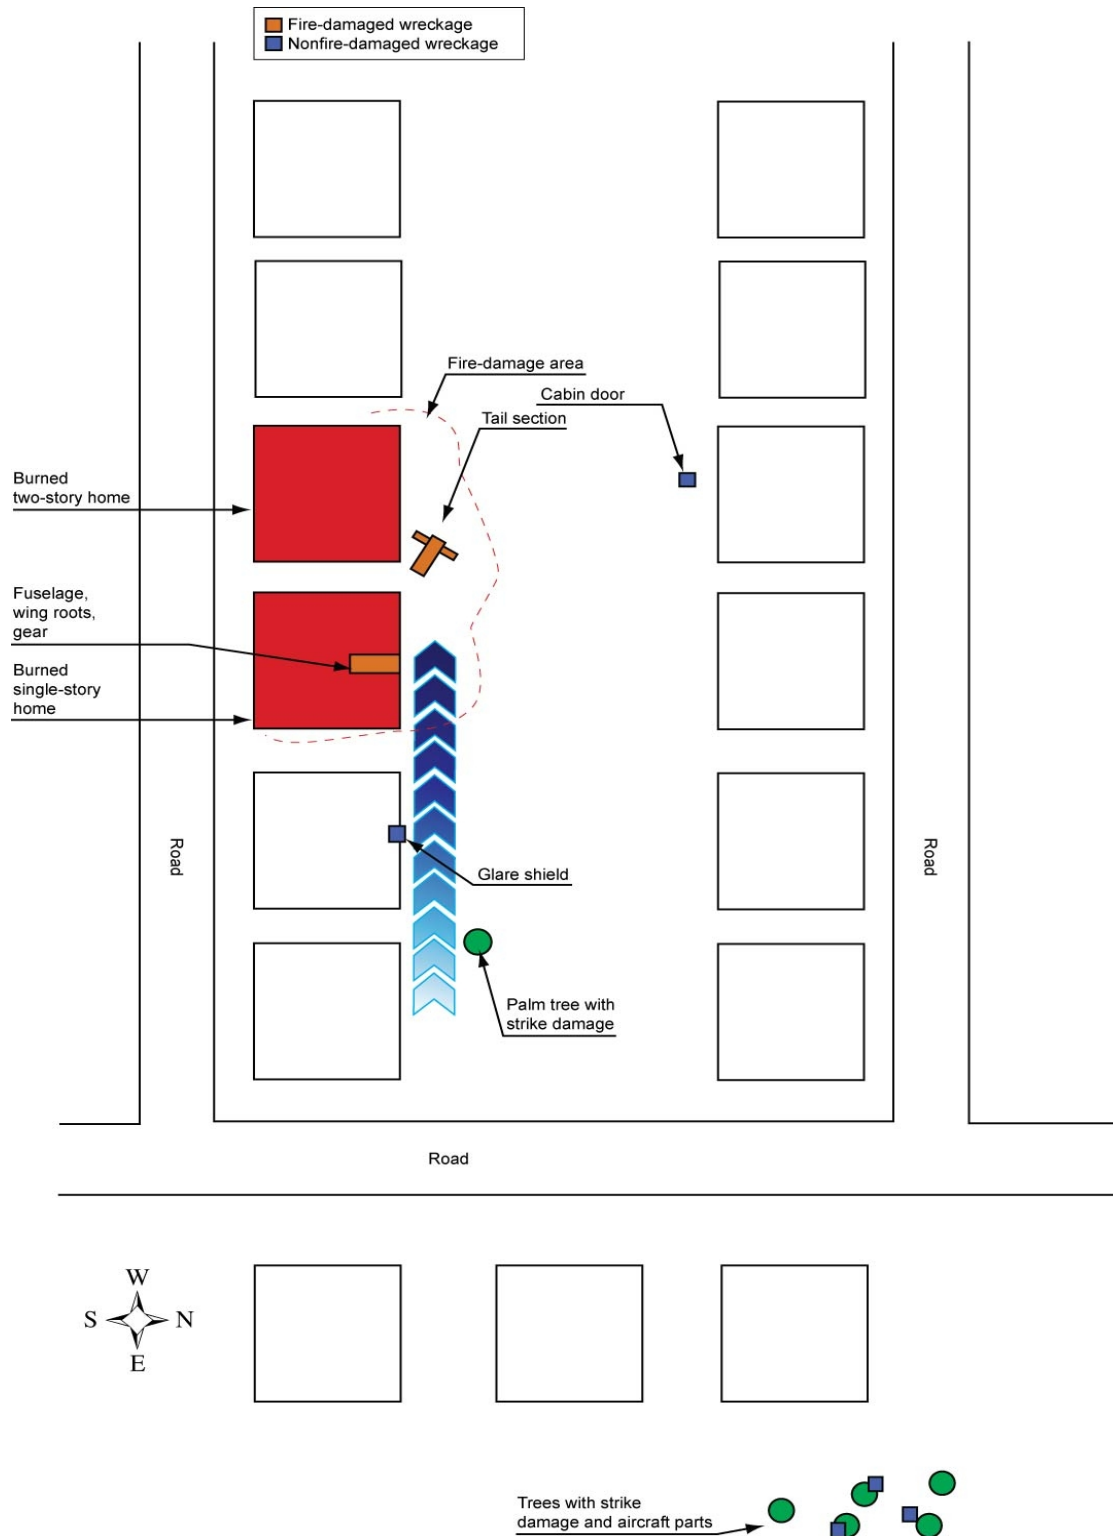
The primary debris path was about 300 feet long and oriented on a westerly (about 255°) heading. The airplane first struck a north-south line of trees in a right-wing-low attitude at a height of about 65 feet agl. About 270 feet beyond the first tree strikes, the airplane struck a palm tree at a height of about 20 feet agl. The airplane then grazed the northeast corner of a house and subsequently impacted the next two houses along the street. A postcrash fire ensued, destroying the airplane and the second- and third-impacted homes.

Figure 2. Diagram showing the location of impacted homes and trees and pertinent wreckage. The blue arrows show the general westerly direction of the airplane’s travel at impact. (Diagram not to scale.)
