THE REST OF THE 787 STORY

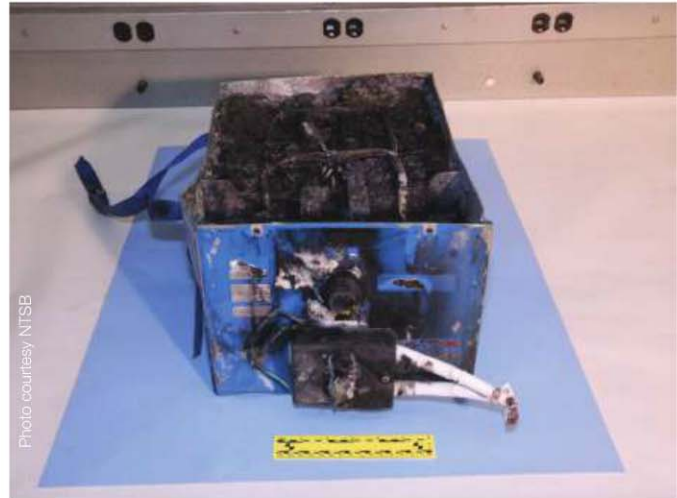
A NTSB photo of the burned auxiliary power unit (APU) battery from a Japan Airlines Boeing 787 that caught fire in January.

This information is a critical part of the puzzle, because it reveals that deep discharge related failure is regularly occurring. When it is too deep, it trips the internal battery disconnect, but when just above this threshold, it sets the stage for a possible fire when the battery is used to attempt a high current operation like an engine start, or is recharged from other sources. At that threshold, it is in exactly the most

While horrified, on some level I was glad to see this data because it provided the missing piece of the puzzle regarding the events that led to the two highly visible battery fires. It especially clarified that the likely causal agent behind these failures was the well understood Lithium Ion Cobalt Oxide battery problems related to deep discharge. The design of the 787 battery pack is such that once the battery discharges too much, it is locked out and failed, and must be physically replaced on the airframe. No on-site repair or recharge is permitted once the battery faults, because destructive battery meltdown is a possible result of this problem.

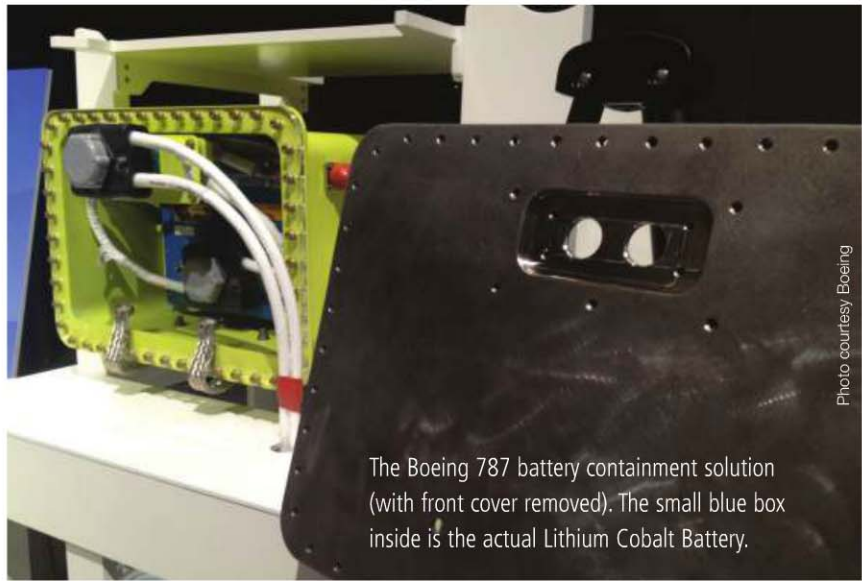
The Boeing 787 battery containment solution (with front cover removed). The small blue box inside is the actual Lithium Cobalt Battery.

It is very interesting to note that while FAA acted quickly to force the battery removal for Cessna, it had a far more forgiving attitude with Boeing. All of the 787s still fly with updated Lithium Ion Cobalt Oxide batteries, but are now housed in a heavy, externally vented fire containment vault. I am sure the logic of this solution has puzzled a lot more people than just me, especially since a turn-key, non-flammable solution (without discharge problems) exists in-house with the proven 777 battery system, or some variant of the Acme FNC cell technology.
