White Paper

Beechjet Landing Gear Down-lock Switches

Bob Nuckolls, Sr. Engineer/SME
Raytheon Aircraft Company
Phone 316-676-3286
Bob_Nuckolls@rac.ray.com
Revision –A- 11 February 2004
Revision –B- 13 February 2004
Revision –C- 12 March 2004

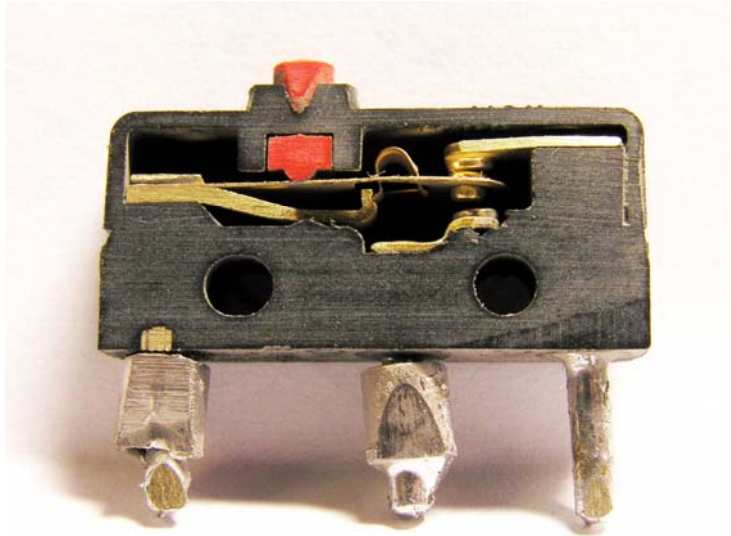
Two switches were opened for inspection. None showed any signs of corrosion or contamination.

Rivets were drilled out and individual basic switches were separated from the assembly. A photo to the left illustrates a cut-away view of one of these switches.

After cutting the side out of this switch, it appeared to operate normally. The over-center spring operated as expected in response to motion of the plunger. Sanding dust was rinsed out of the switch and the switch blown dry. Resistance measurements made earlier repeated. N.O. contacts had no continuity; the normally closed contacts measured 10-20 milliohms resistance.

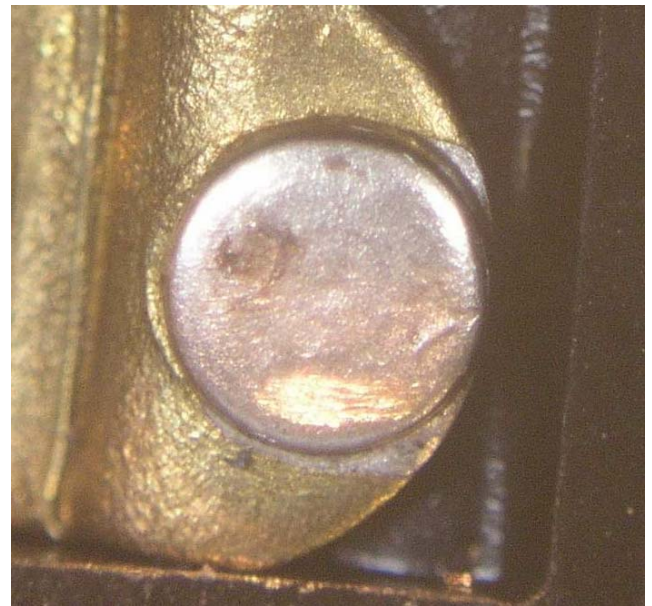
Under the microscope, no metal transfer could be observed between N.O. contacts in profile. The switch was further disassembled for microscopic inspection of contact faces. These photos are typical of N.O. contacts of both failed switches.

The photo to the right is typical of N.O. stationary contact on the failed switches. There is a darkening of the area inside a shallow ring of transferred metal where the contacts come together,

This delay allows closing contacts to become stable before they are loaded. Adding the “contact saver” to the lamp circuit will stop the metal transfer and arcing damage to the contacts depicted in earlier photos.

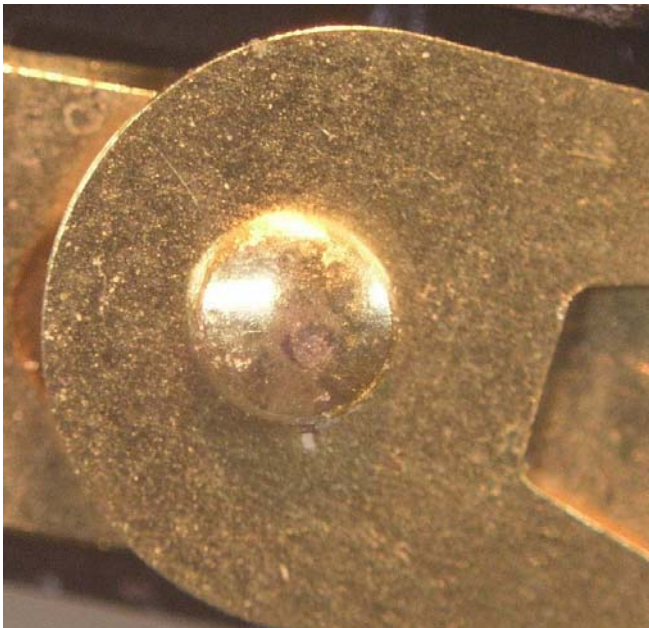
The photo to the left is the movable N.O. contact which shows an unremarkable wear spot.

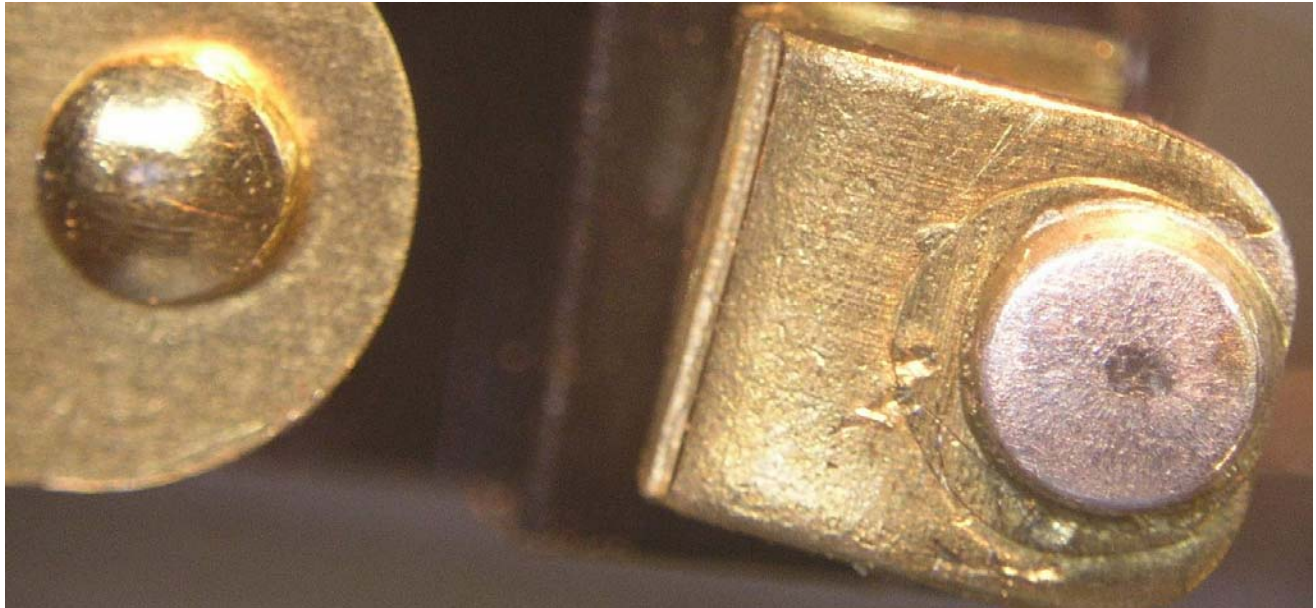
The photo above is typical of the N.C. contacts of both the failed and normally operating switches. The contact on the right shows some darkening in the interior of the arcing pit but neither contact shows metal transfer.

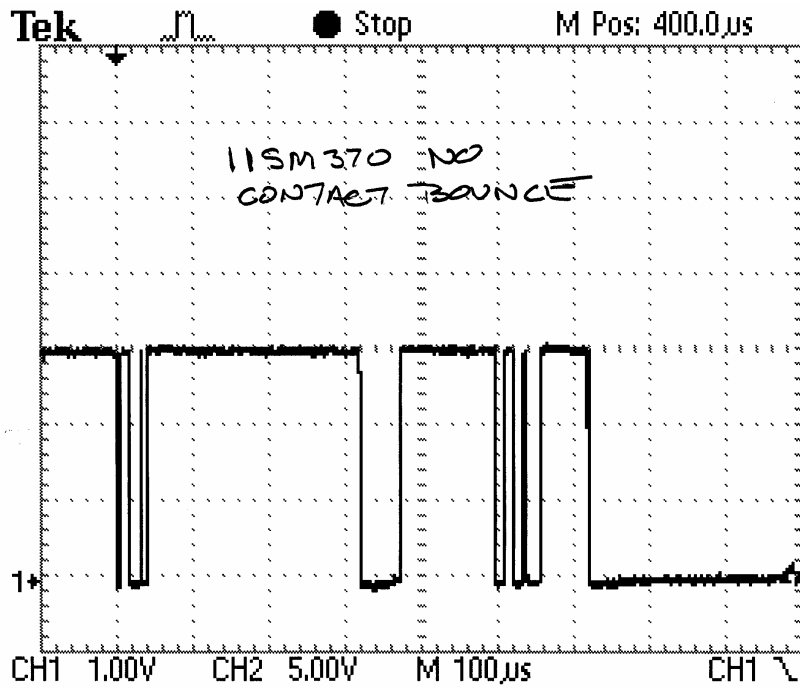
The working switches removed from the two test articles were tested for contact bounce. A plot on the left illustrates voltage across the N.O. contacts of a switch when actuated to the closed position.

This plot is typical of several operations and both switches. The contact hit at least 8 times over a period of 620 microseconds before becoming stable.

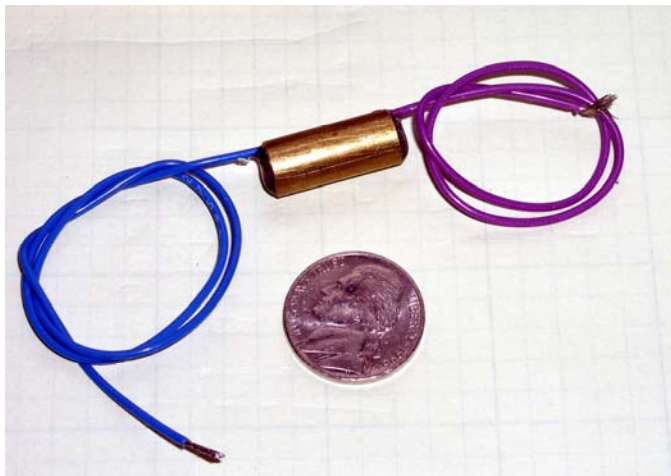
A rudimentary prototype of the above circuit was crafted and potted into a short segment of brass tubing. The resulting assembly is compact and suitable for electrical splicing into the lamp circuit with mechanical support by tying into a wire bundle.

This circuit operates without need for separate supply or ground leads and is therefore easily added to the troubled lamp circuit.

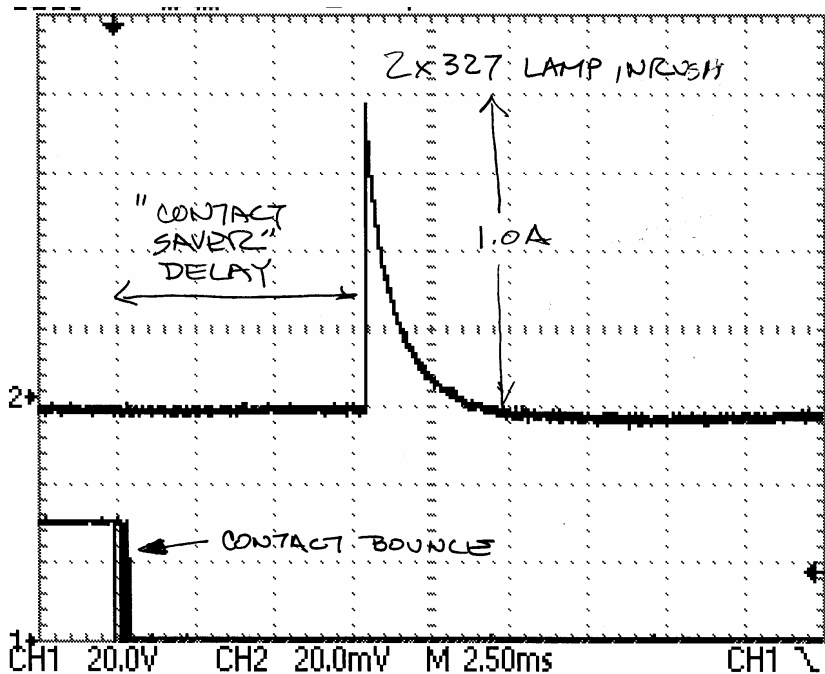
This plot illustrates the benefit of adding the proposed delay circuit. The lower trace shows contact closure and bounce while the upper trace plots circuit current.

Contact bounce happens in an UNLOADED condition over the previously observed 500-600 microseconds. Onset of lamp current is delayed by approximately 7 milliseconds. The “contact saver” has approximately 800 millivolts of drop in the ON state.

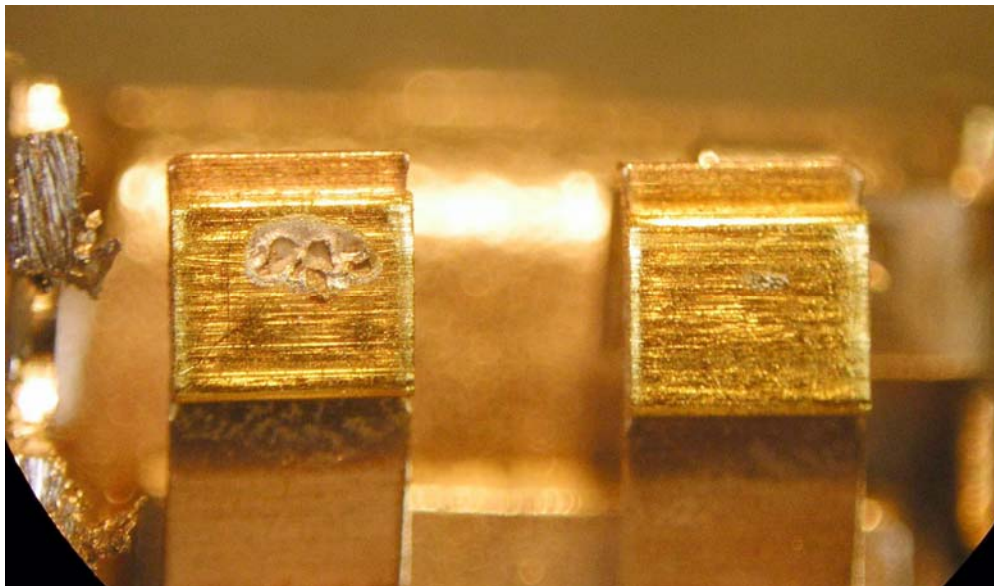
In this view, the contact on the left shows pitting typical of relays suffering the failure mode demonstrated in Beechjet’s roll trim system. This contact began sticking after 27,000 cycles.

The contact on the right was cycled stick-free for over 300,000 cycles.

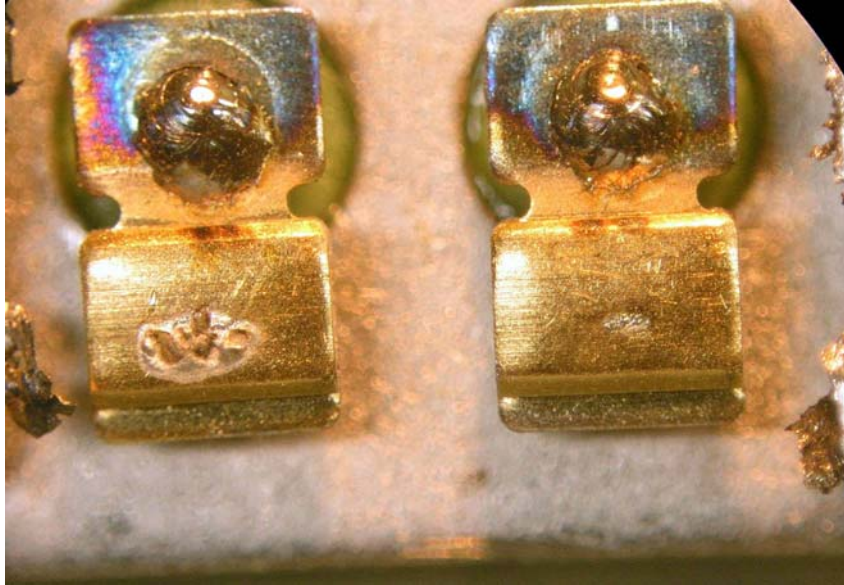
This is a view of the stationary contacts on the same relay. Metal transfer on the 27K cycle contact is profound.

It is interesting that while metal transfer on the 300K cycle contact is very small, it is NOT ZERO. Under the 3d microscope, tiny separate mole-hills of metal can be seen rising from the contact surface.
