400EXXX

BEECHJET ROLL TRIM RELAY FAILURE ANALYSIS

RECOMMENDED CORRECTIVE ACTION

Date: August 18, 2004

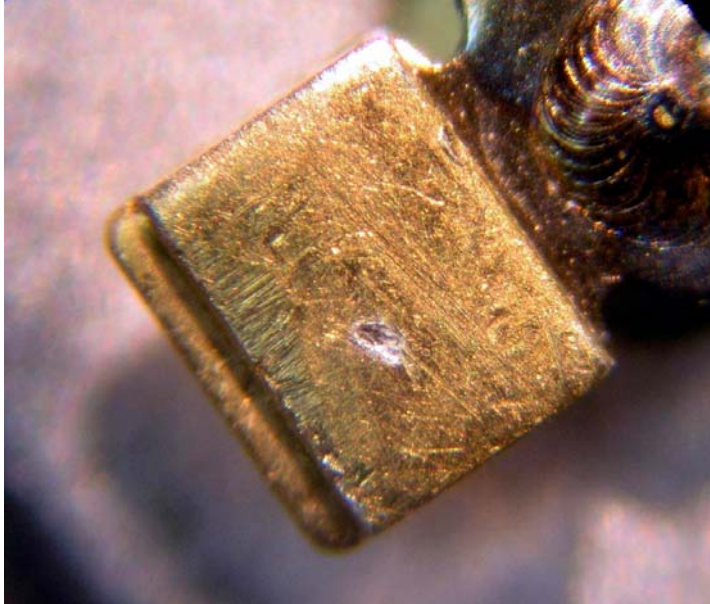
The adjacent photo illustrates contact condition after a life test of production relays by the present supplier (Deutsch). The manufacturer informed us that profound metal transfer illustrated in the photo is normal and typical of a relay that still meets requirements for life testing at the

Failed relays from the field were opened at RAC for inspection. Contact metal transfer in these devices was a small fraction of that illustrated here. The most affected contact had less than 5% of the surface area exhibiting any evidence of metal transfer. While metal transfer may participate in the sticking phenomenon being observed, the

absolute magnitude of metal transfer is not a major clue as to root cause. Clearly these relays can continue to function within specified limits in spite of significant metal transfer. As a part of their QPL requirements, Deutch routinely demonstrates that the relay meets operating requirements in spite metal transfer several times more severe than troublesome relays removed from the roll trim system.

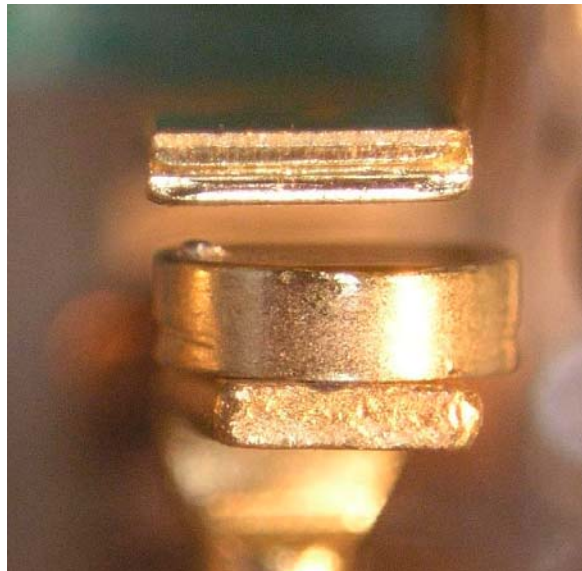
The adjacent photo is typical of sticking contacts in relays returned from the field. The volume of transferred metal was very small with the contact showing no signs of electrical abuse.

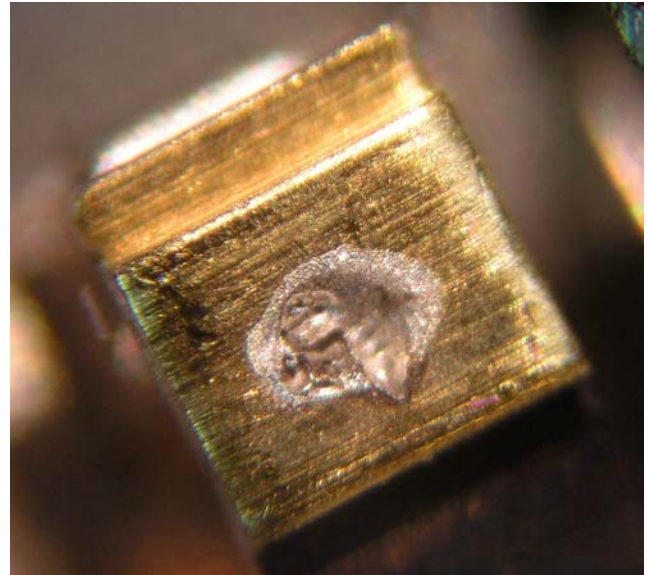
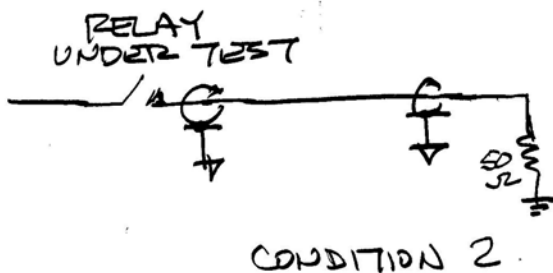
Condition 1. The first test condition is described in this sketch where all components emulating the aircraft configuration are in place: The first test article ran for 500K cycles on the section A contacts without sticking but metal transfer was spectacular.

This view shows footprint of the crater for moving contact of Section A. In spite of this remarkable metal transfer, the contact was still operating freely after 500K cycles.

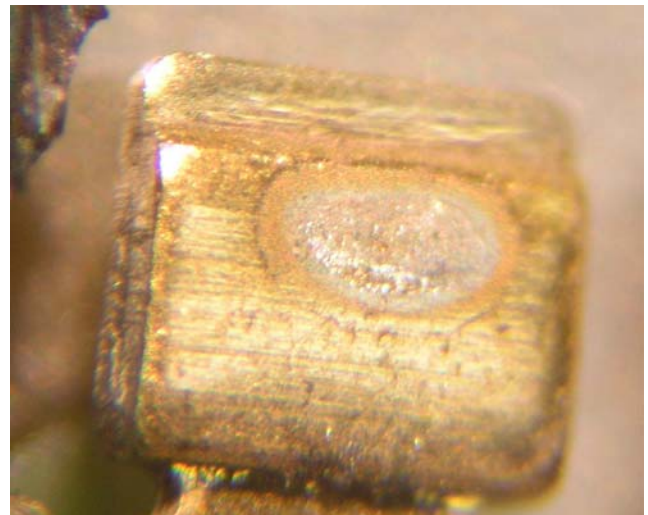
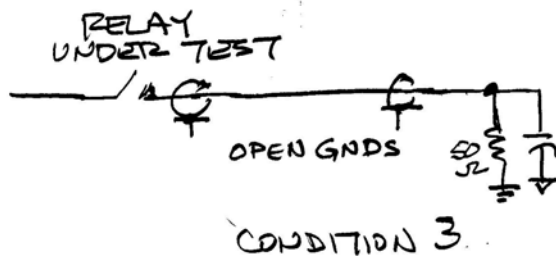
Condition 2 A second test article was run with the RFI filter capacitor removed.

This image is typical of both sections of the second test article after 500K cycles. No significant metal transfer. Both moving and stationary contacts showed a wide area of contact participation with little sign of erosion.

Based upon studies cited above a minimally intrusive solution to contact sticking problems in the Beechjet's roll trim system is to simply remove the existing noise filter. The Circuit Effects investigation demonstrated that removing the filter reduced contact wear to rates on a par with dry circuit switching of the same current levels.

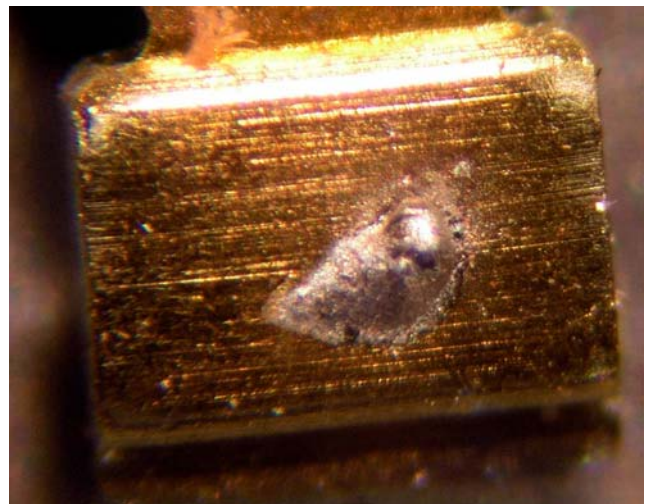
Condition 3. A third test article was tested with both load resistor and filter capacitor in place but with shield ground disconnected.

Section A ran 500K cycles without sticking. This view shows profile of the metal transfer pip on the stationary contact.

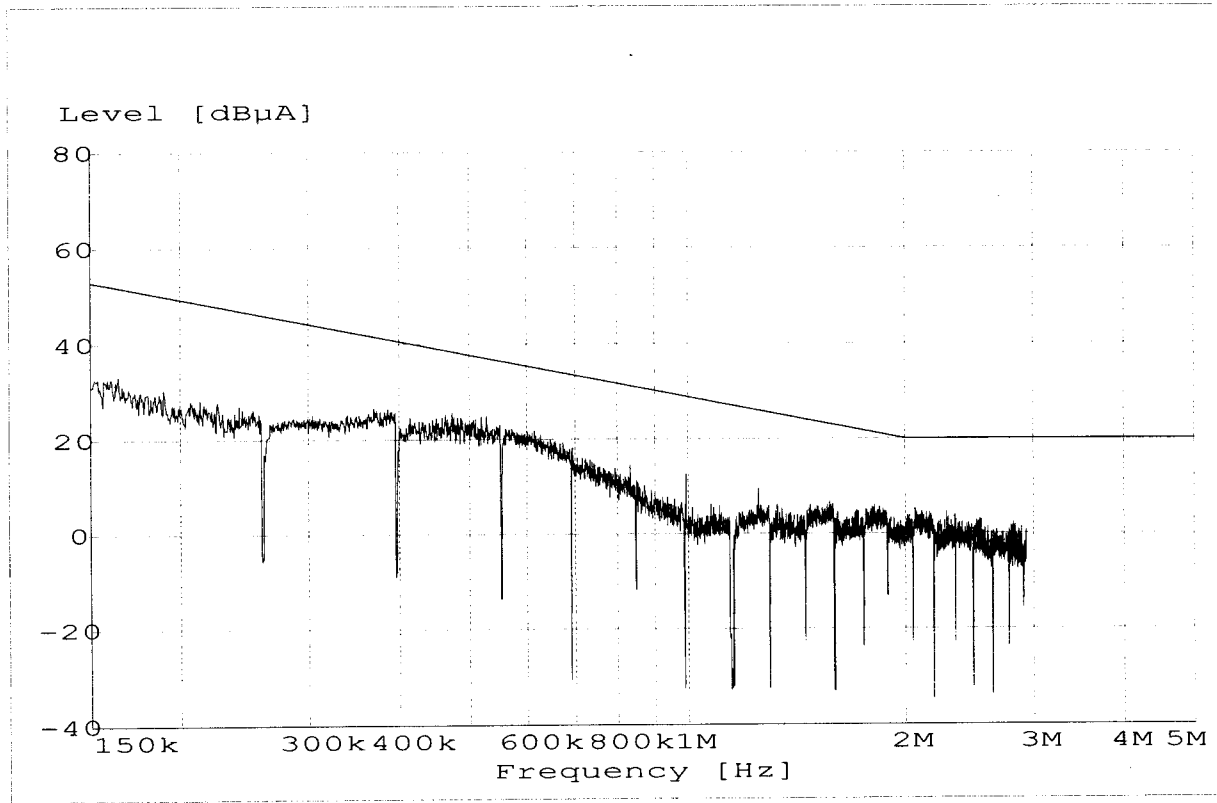
On March 26, 2004, a roll trim actuator from the system simulator was tested for conducted emissions per DO-160, Curve M. Results of that test are illustrated in Appendix A, Figure A-2. Noise emissions from this actuator plotted at 15-20 db below the upper limit for the range 150 KHz to 3 Mhz. This preliminary test suggests that while the actuator's noise output is not zero, it's quite small compared to DO-160 limits without benefit of a noise filter.

- The noise filter capacitor is not necessary. DO-160 conducted emissions tests on a roll trim actuator show that noise generated by the motors in this product is sufficiently low to not require external filters.
