Why you Should Know your ECU; Three Case Studies

Why you should know your ECU; Three case studies.

CASE STUDY ONE

CASE STUDY TWO

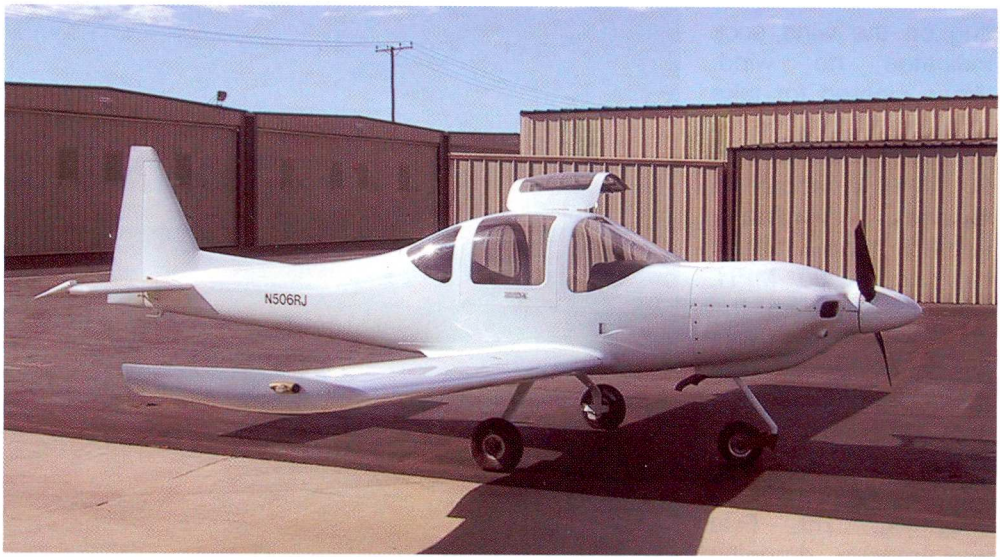
N506RJ before its first flight on January 3, 2006

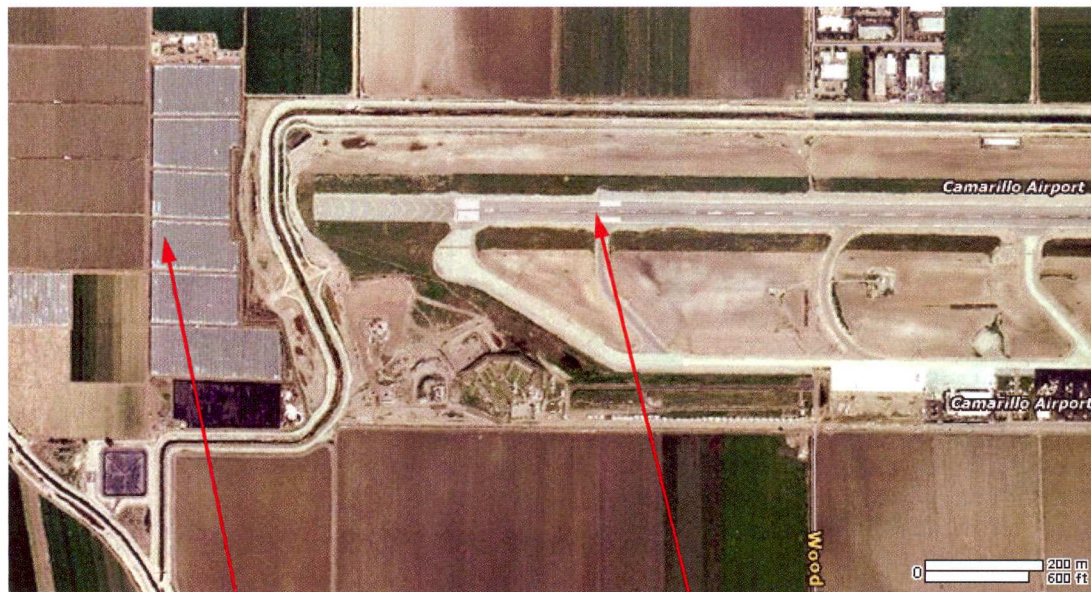
Crash site

Limp-home mode started here

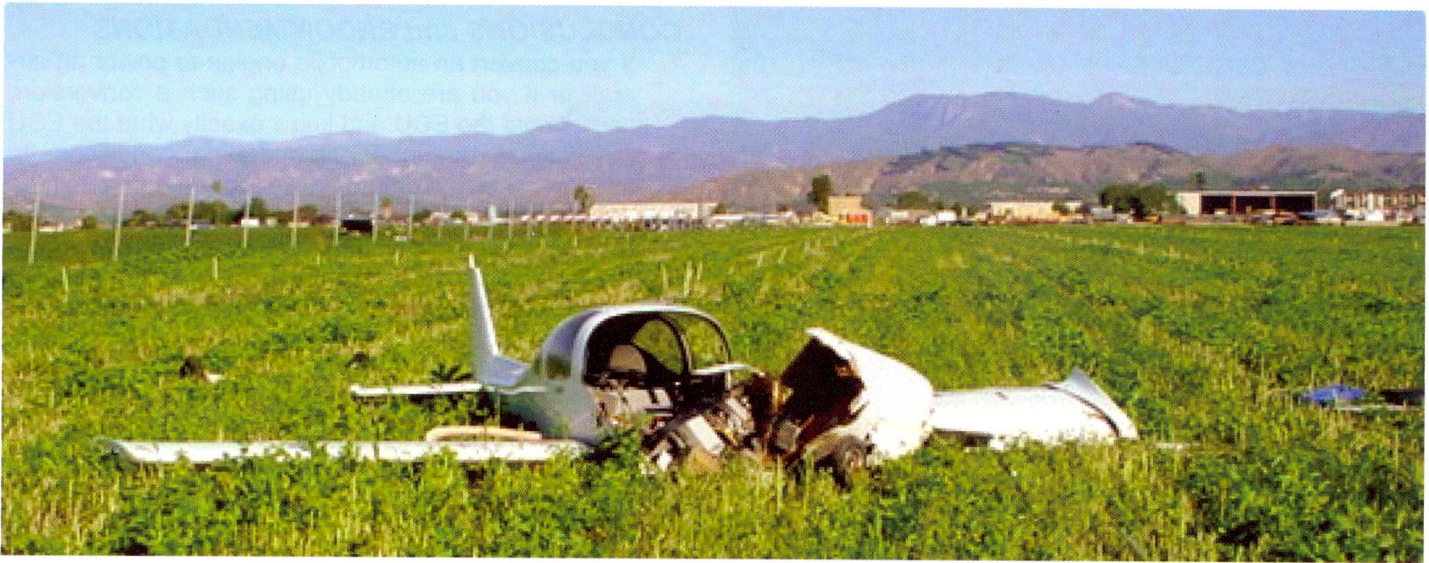
N506RJ after its second flight, at rest in the celery field adjacent to the airport.

settled, I opened my eyes and the remainder of the celery crop was just beyond my feet. The nose of the plane had taken a left turn probably because the engine was still running and the prop was still turning at about 1,100 RPM. I estimate that I decelerated from 88 FPS (60 MPH) forward speed (and about 8-10 feet per second descending) to zero in about 30-40 feet. My tail low strategy worked in the soft field. The plane had not flipped over. The main gear was located about 30 feet behind the final resting place. The folks who removed the plane from the field said the nose wheel had nicely folded back under the plane and gouged a ditch about a foot deep and about 6-8 feet long that was visible when they lifted the plane onto the truck.
