Reassembly

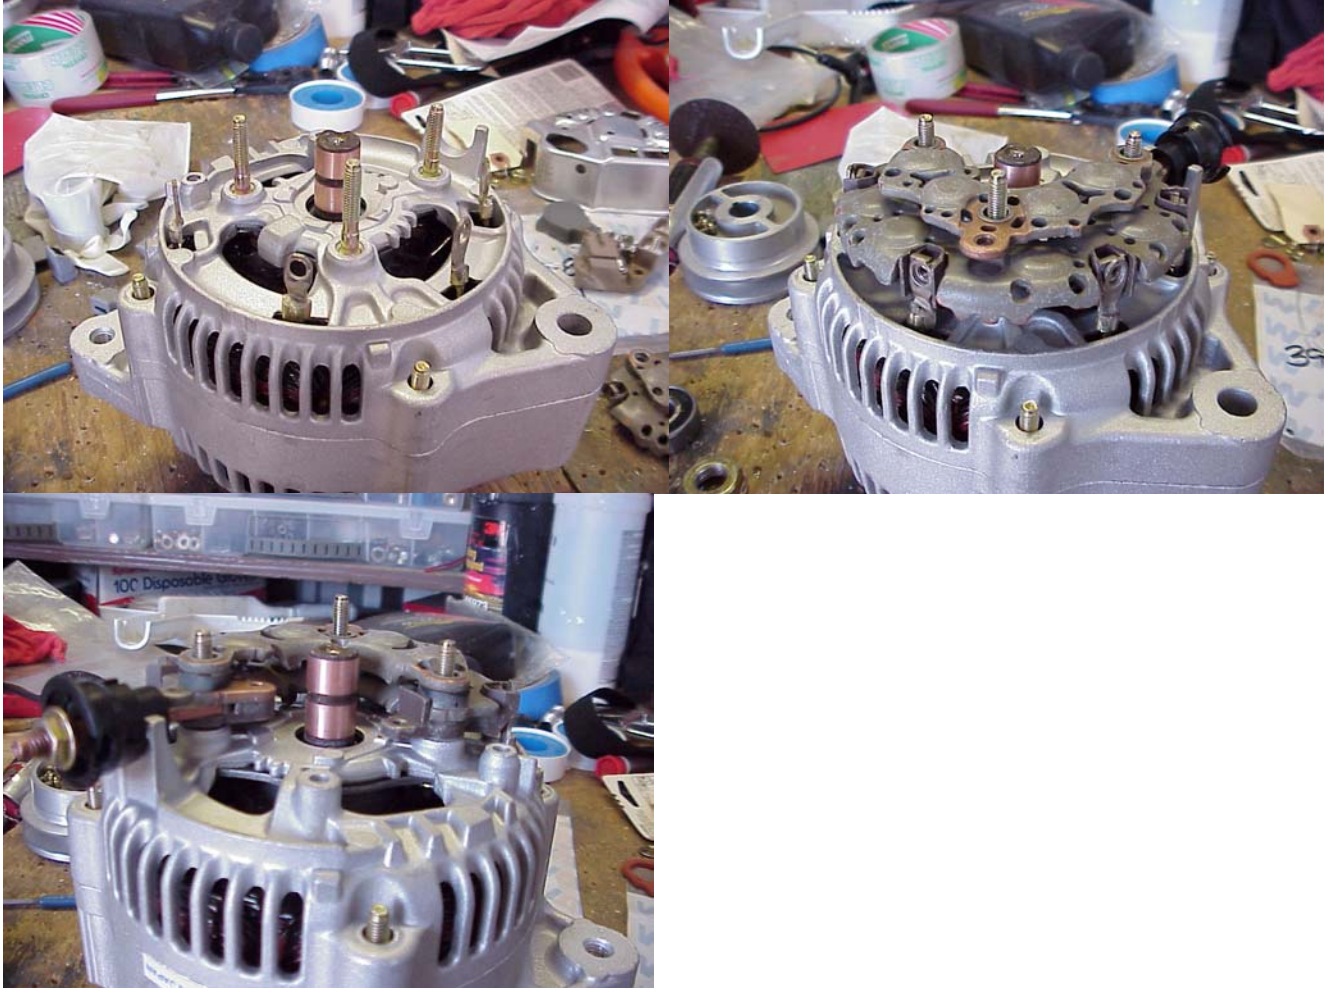
The next 3 images show the unit going back together, and as you have probably noticed I forgot to put all the rubber boots on. So take it all apart and do it all again if you are like me, and need the practice.

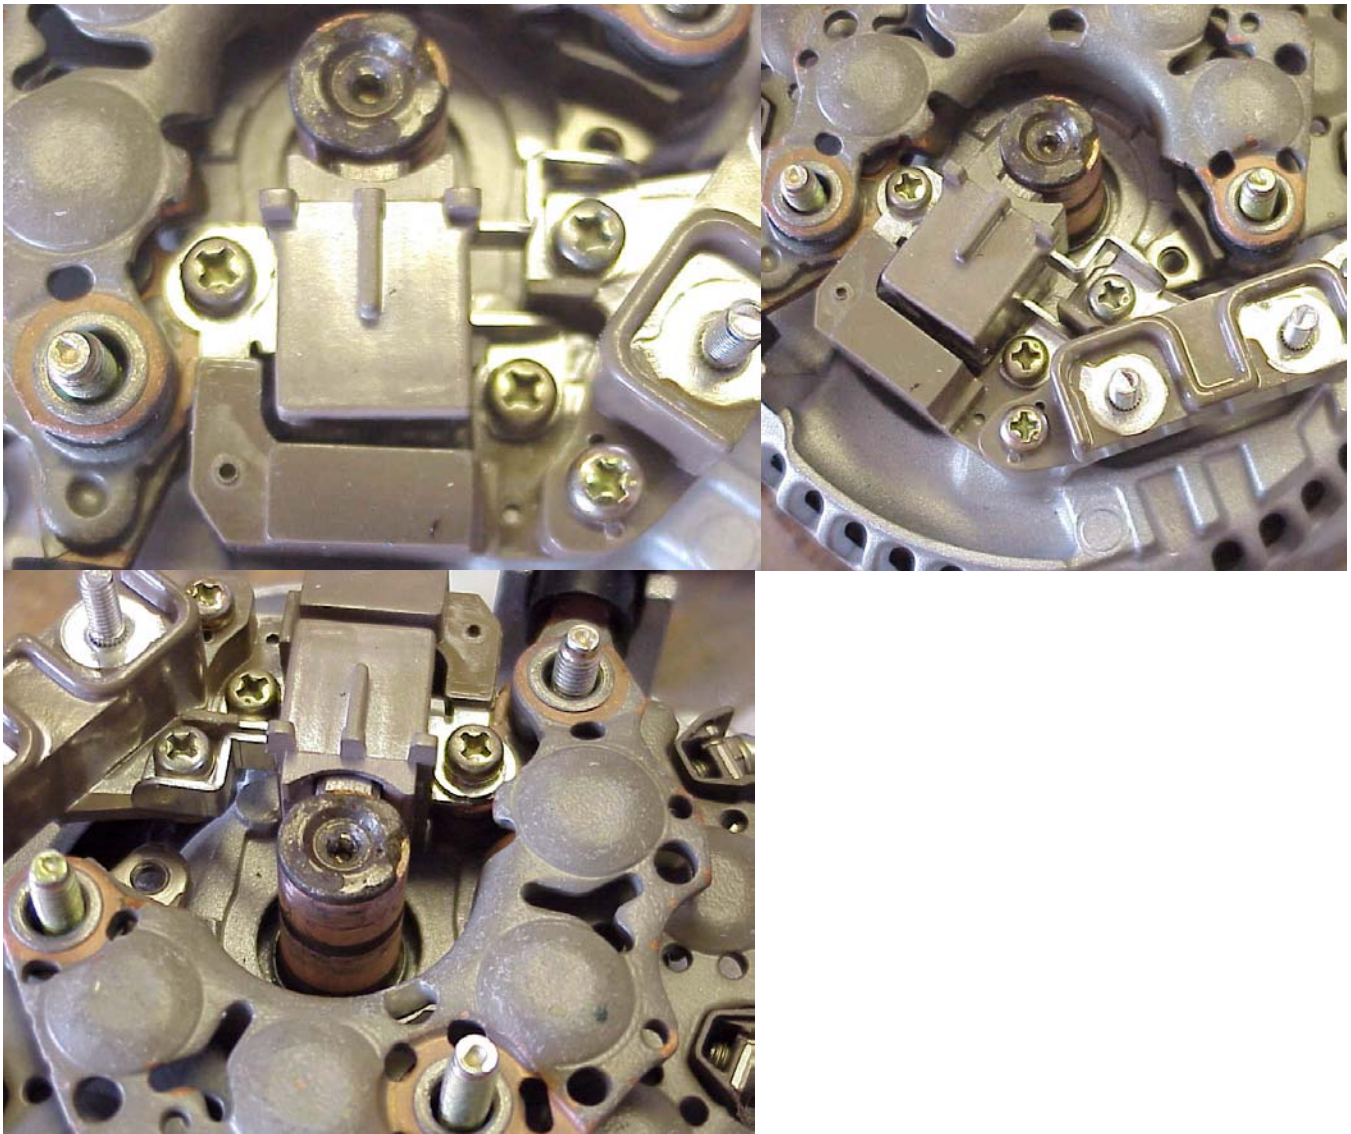
The two images below show the new brushes and terminal blocks going in place, and, once again you have probably noticed that I forgot to install the lower brush red boot.

Also note the overlap of the left brush screw.

This tang for the brush does nothing but hold it in place in spite of the fact that this lug on the rectifier is part of the positive lug. The left most tang on the terminal block that overlaps this goes to one side of a noise filter cap in the terminal block. It needs to be square to the brush assembly lug for the brush assembly to sit square to the slip rings. It will cause the left part of the terminal mount to look like this, but this is just the section that has the filter cap in it.

The other two lugs on the right side of the brush assembly go to the two terminals.

One terminal lug goes to ground and the other comes from the external regulator once the unit is assembled and installed.

It's important to check that the brushes are well aligned and squared to the slip rings.

If they ride slightly high or low this is OK as long as they make full contact.

One way to reduce regulator noise is to use a shielded wire from the reg.

Have the inner conductor go from the reg to one post, and the shield go from the other post back to the reg area, where it's there.

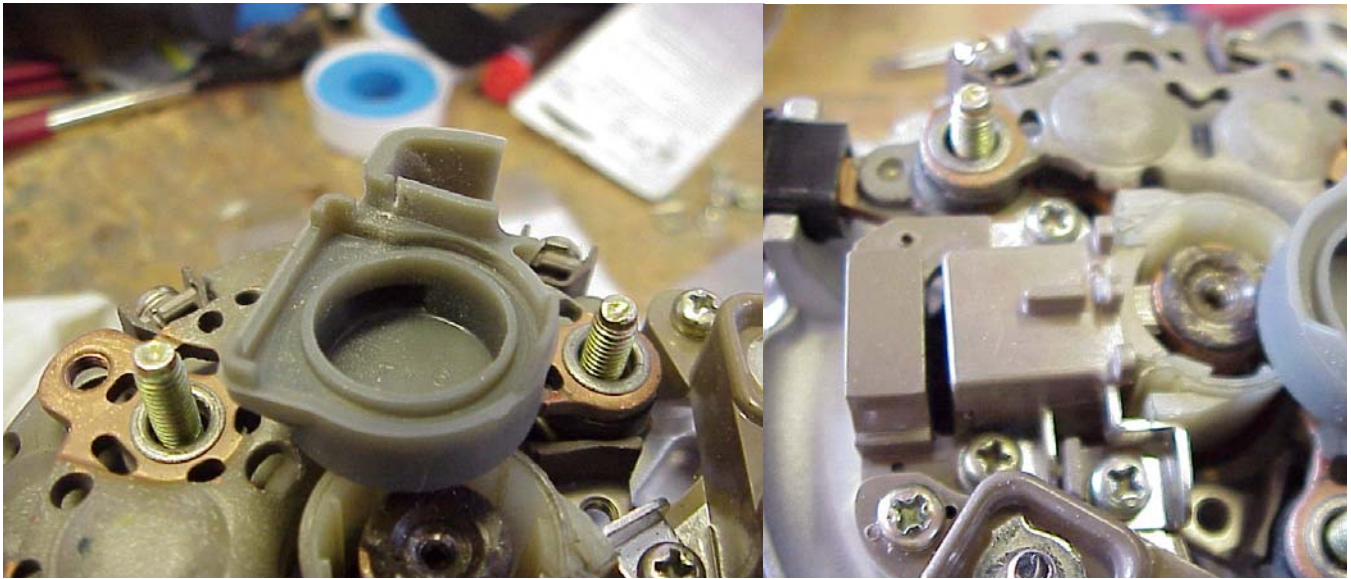
These next few shots show some slight trimming (slots) I had to do to the aft rubber boot and the new brush assm. to make the
Note in the right picture the white plastic brush cover half cylinder. This is held in by being trapped between the alt. rear case a

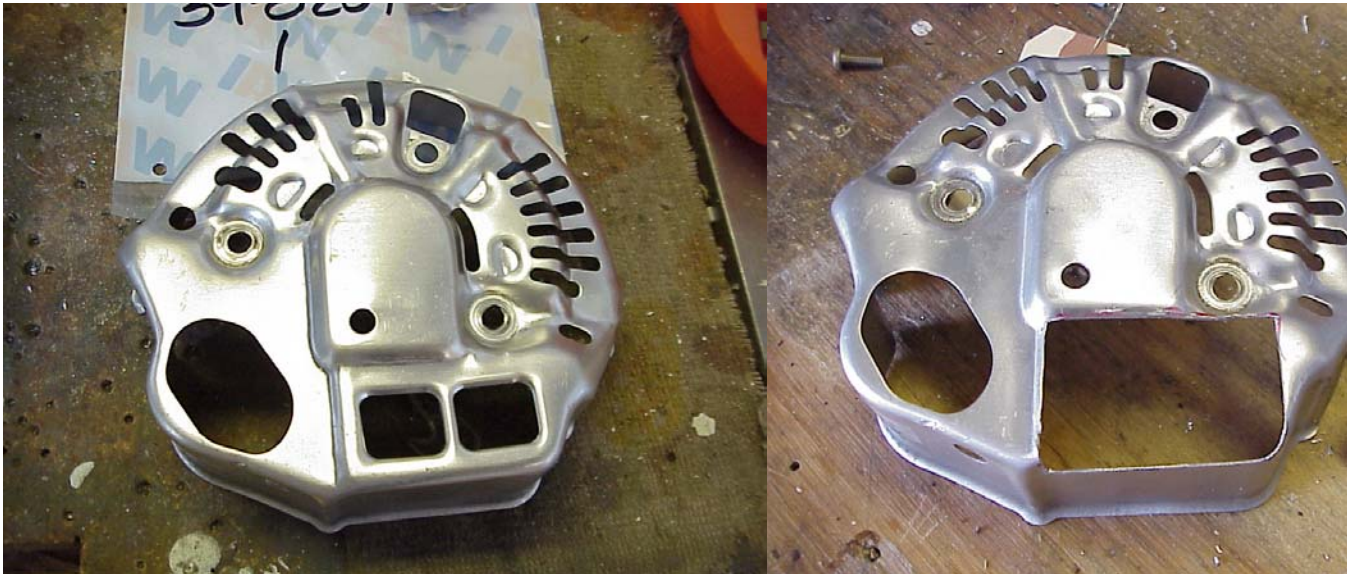
This shows the rear cover modified to fit the terminal block.

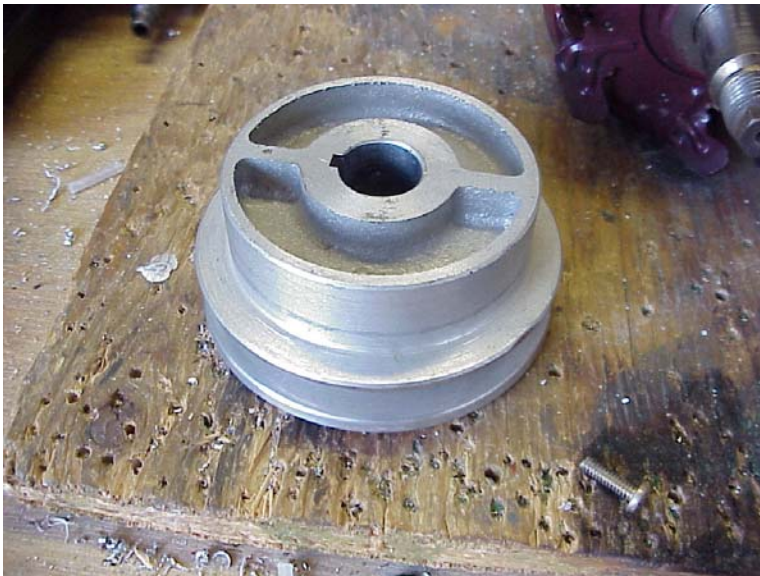
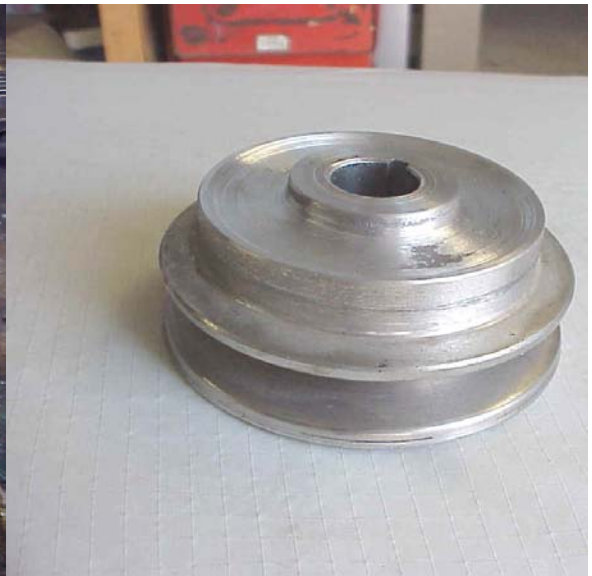
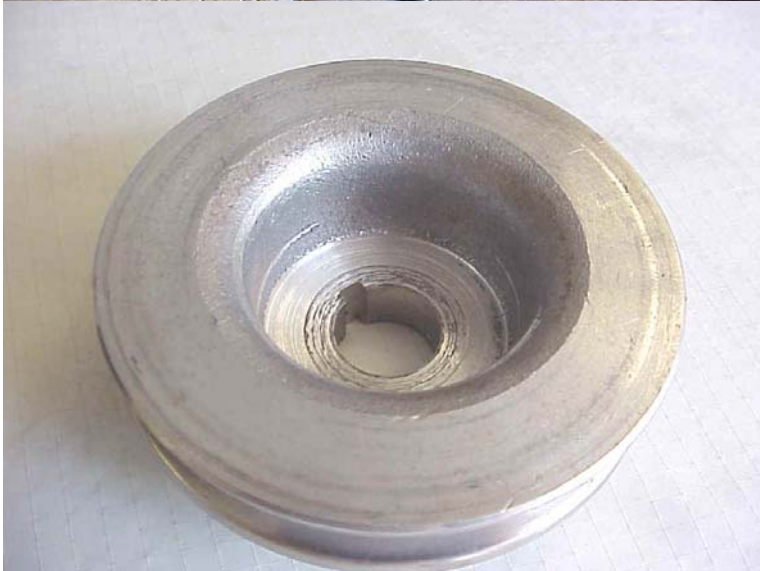
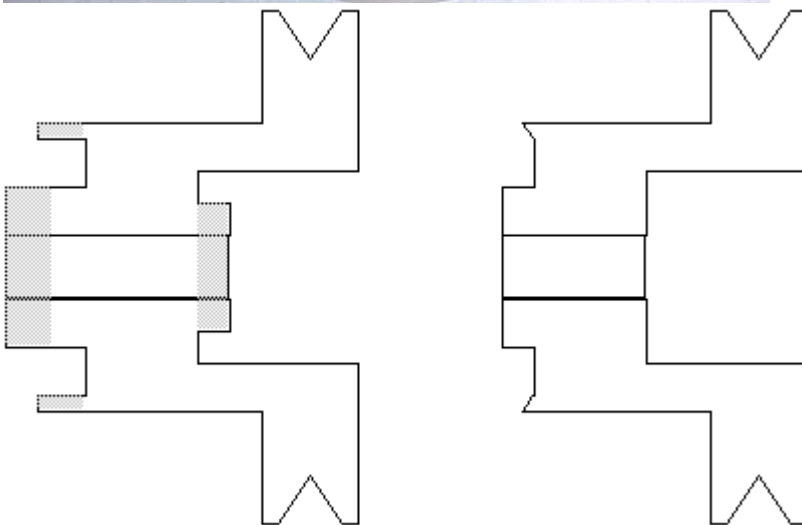
The following images and drawing show the Prestolite pulley as new and as modified. The aft side has a collar and web that ne removed, then the aft stepped boss needs to have about 5mm removed from it. Inside the front of the pulley there is also a boss step that needs to be cut flush. This should leave about 10mm of depth in the j boss to correctly position the rotor and leave enough room for the nut to engage. Make sure you leave enough of the aft boss s face of the pulley doesn't rub the front alternator case. Use the original pulley as a guide. The key is not needed. In fact all new alternators don't seem to use keys anymore. Use a strap wrench and torque wrench to tighten. I went for 30ft/lbs. I also put some torque seal on this for inspection purposes

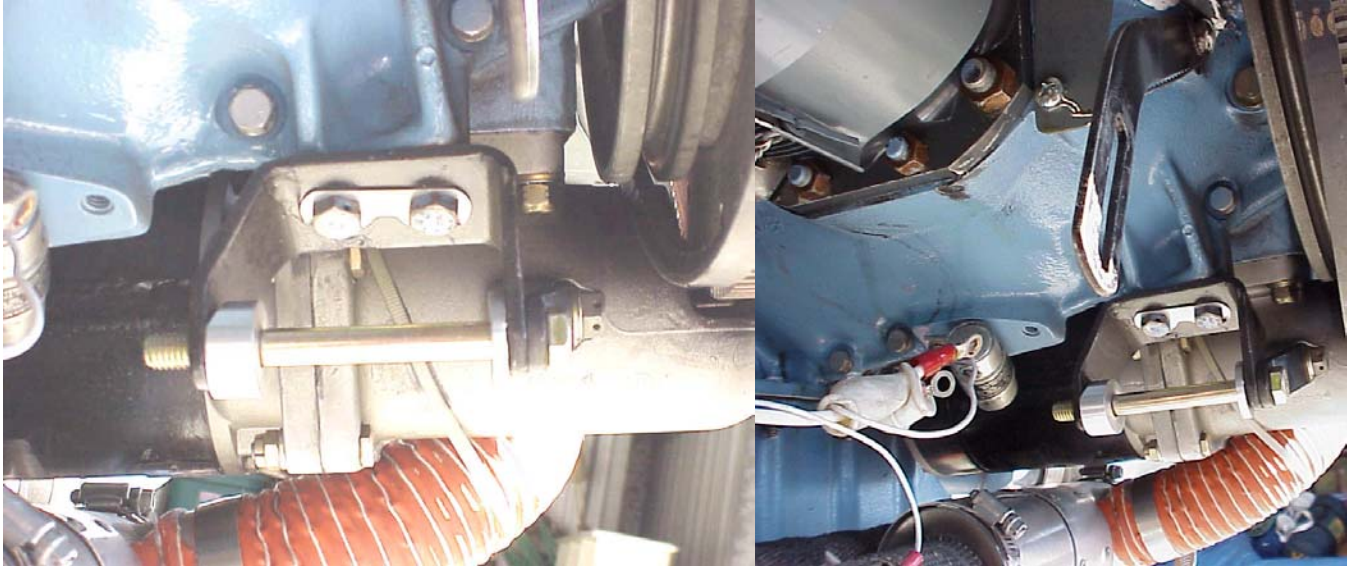
These two show the steel Lycoming boss mount with the new bolt and the two shims. These are 1" diameter and 0.135" for the front, 0.475" for the rear, with a 3/8" bore.

The rear one needed to have a corner shaved a bit as the mount is angled there.
These shims can be different if you have a different boss mount. Its important that the pulleys line up as closely as possible so these measurements..
The main bolt is 4.5" x 3/8" NC and the adjust arm is a 8mm x 1.25 x 40mm.
This latter length leaves enough room out the back to lock nut the adjustment fastener.

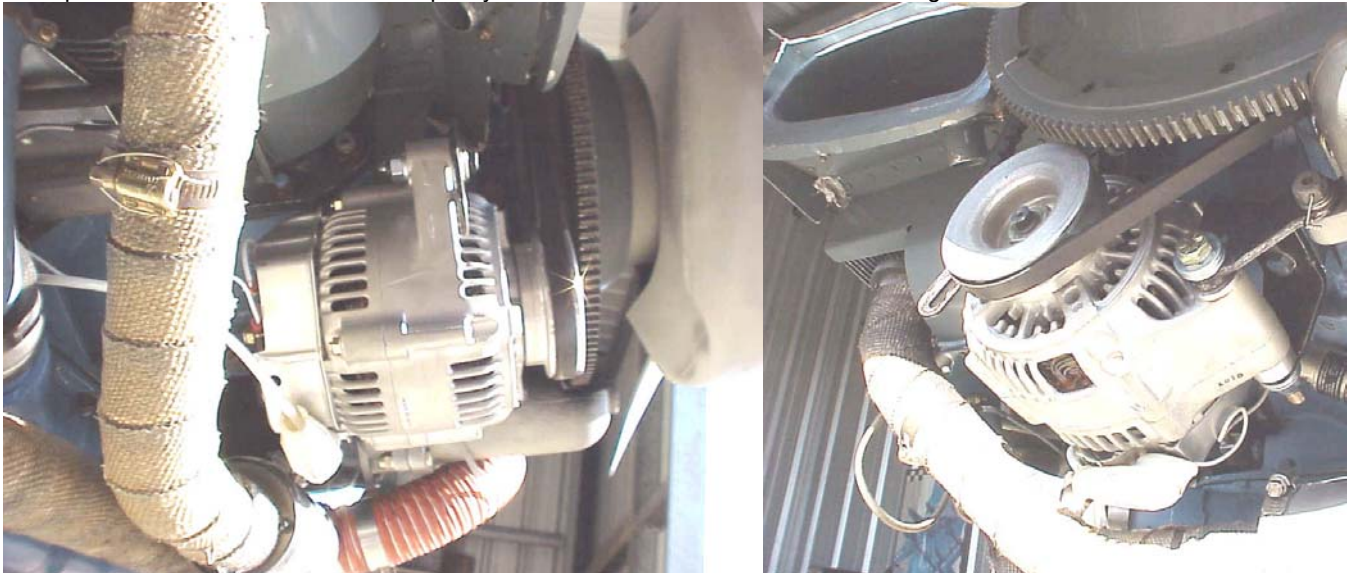
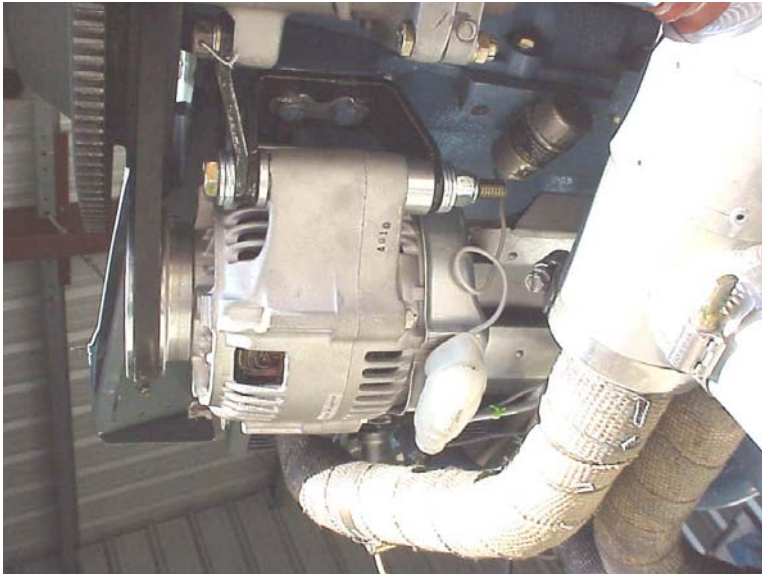
These last few show the new alternator installed. I was able to use the same belt and swing arm, but the slot on the arm needs 1/8" upwards. If I had wanted there was plenty of room in the cowl to install the next longer belt.

The currently installed main bolt is a 5" and is somewhat long, but the 4" didn't have the grip make it all the way through the alte mounts. It seems a 4.5" x 3/8" grade 8 will take a special order to locate.

Its also very important that the tang that goes from the forward mount over to the starter be installed. This is true for any of the l
