Wired for Disaster

This article appeared in the August 2004 issue of Sport Aviation. The author attempts to share insights into the hazards of aged wiring in airplanes. A detailed review of the article raises more questions than answers. The article is long on platitudes and hyperbole, short on data and sprinkled with errors. There have been previous articles appearing in the Sport Aviation with a potential for creating confusion and suppressing confidence. This appears to be another such article. Therefore, I've taken the time to craft and publish the following critical review:

Bob Nuckolls
March 9, 2006

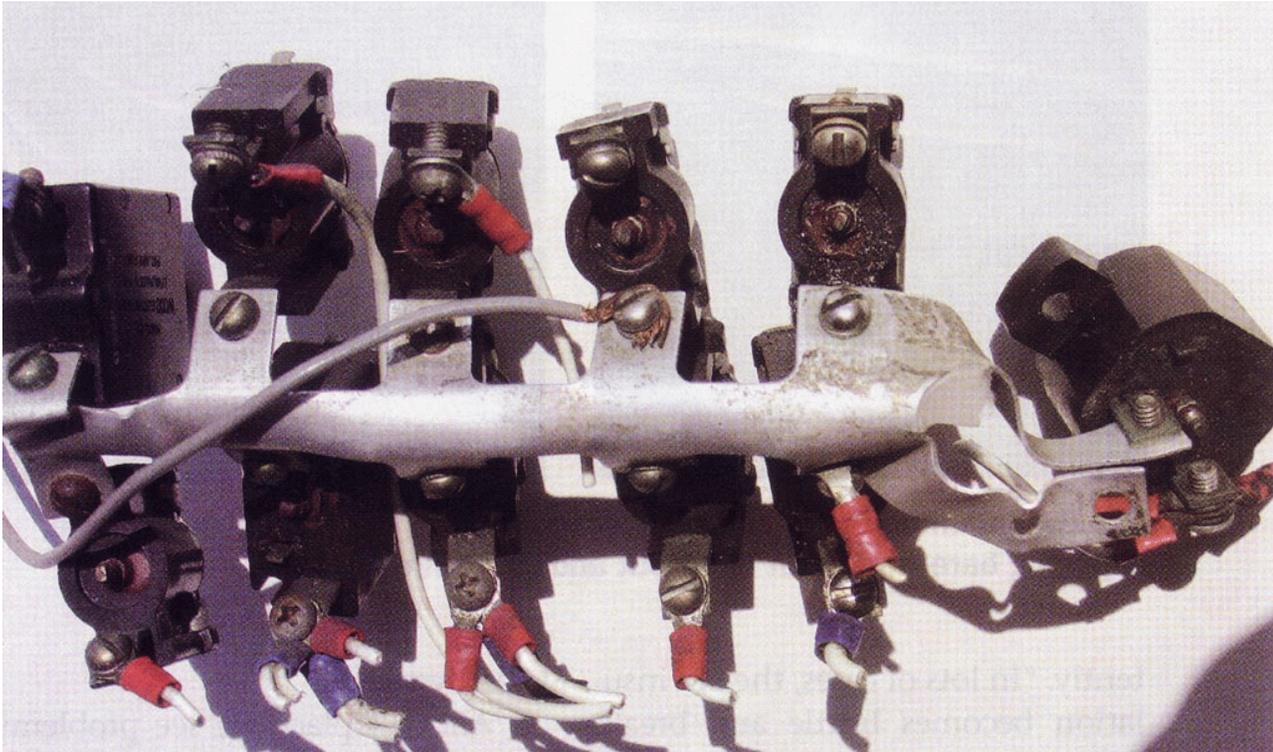
the fact that this breaker assembly must have come out of a wreck (I'm assuming this is how it got all bent up) it appears to be in pretty good shape. All the wire insulation is in good shape. The screws were reported to be "loose" but given the unknown pedigree of this assembly, we can't be sure this condition prevailed while the assembly was still in service.

This is not a very good example of aged materials that might put an airplane at risk. My biggest concerns for an airplane fitted with this breaker assembly center on the breakers themselves. Properly applied PIDG terminals on well tightened screws are going to be just fine. This assembly shows no marked signs of insidious corrosion. The breakers, like switches and relays have low pressure, spring loaded contacts that may not be making good contact. Heavily loaded breakers like pitot heat and landing lights are at risk for smelly failure.

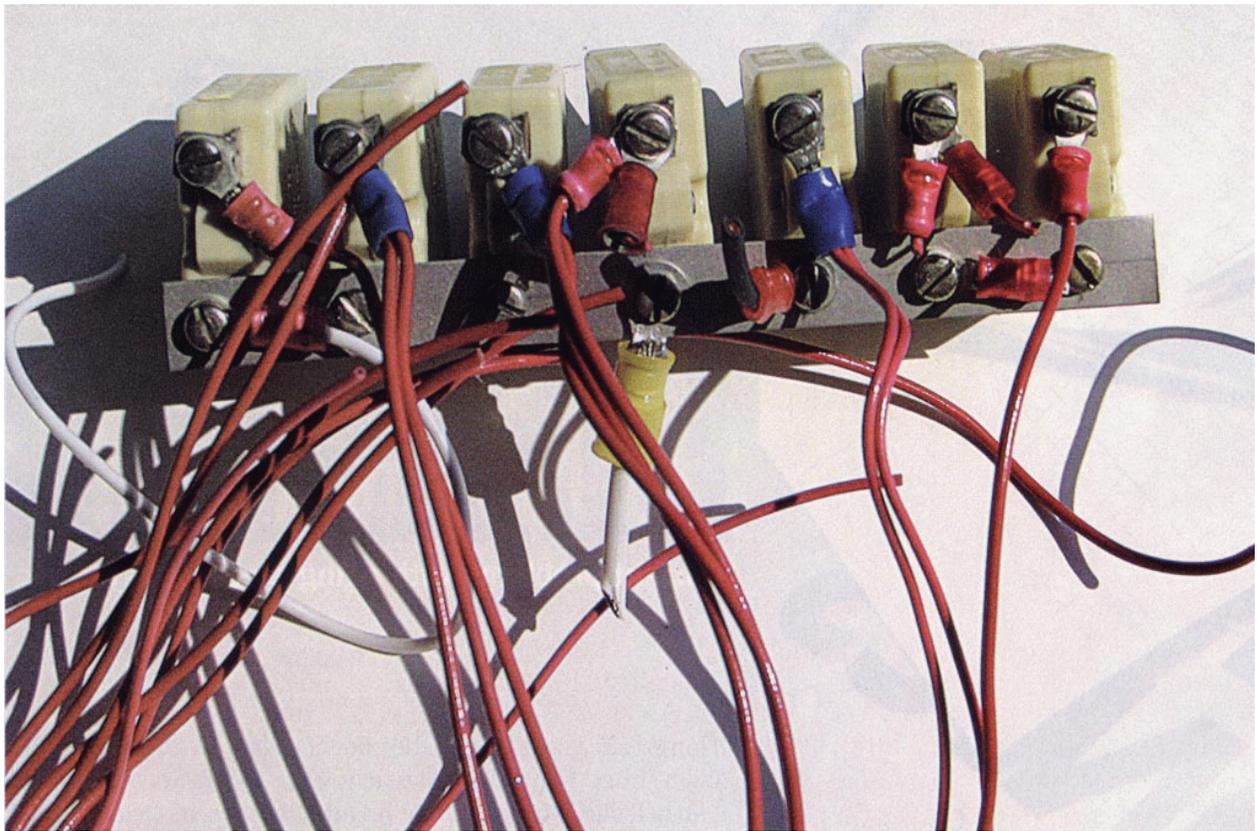
The photo at the top of the next page appears to be out of a OBAM aircraft. None of the terminals appears to have been installed with the proper tool. Many of the PIDG terminals have not been closed down at the insulation grip.. We also see a few "Plastigrip" terminals . . . definitely not recommended for any vehicle where anticipated

service life is exceedingly long.

All the wires are PVC and the authors correctly point out that there are better choices for modern wires but keep in mind that over 100,000 certified singles were wired with this stuff and many of those airplanes are

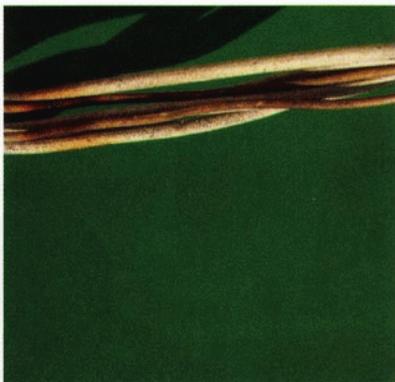
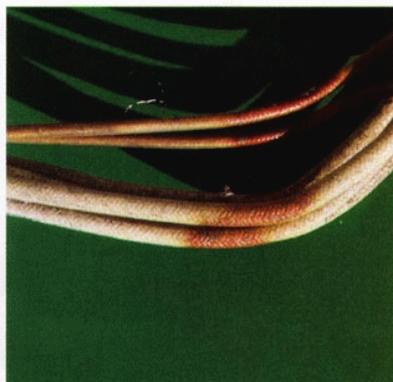
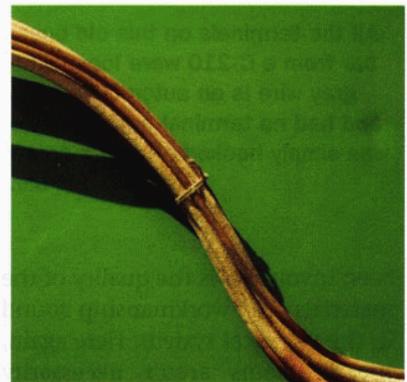
The pictures below are the most mystifying. All three shots show cotton over rubber insulation that might have been used in the late 1940’s and early 1950’s installations. These wires appear to be stained but otherwise in pretty good shape. I’ll bet they’re still flexible. I don’t see any signs of insulation failure. Yes, this is some very old wire but if I were to peek behind the panel of a nicely maintained ol’ C-140 and see bundles that looked like this, I’d go flying without a second thought about it.
