Pilot/Race 177, *The Galloping Ghost*
North American P-51D, N79111
Reno, Nevada
September 16, 2011

NTSB/AAB-12/01
PB2012-102899

Aircraft Accident Brief

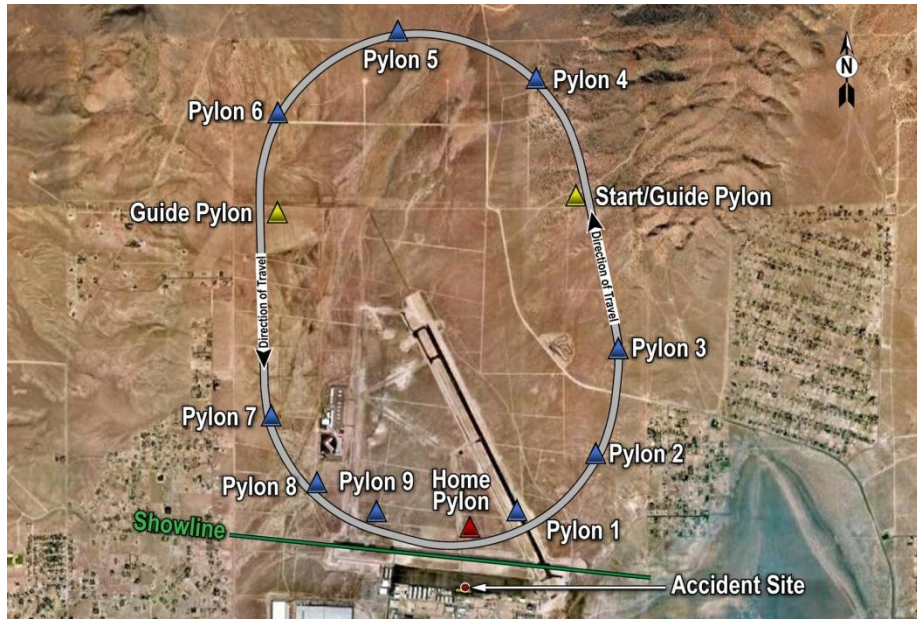
The accident airplane was in third place during the third lap of the six-lap race, trailing the second-place airplane (*Voodoo*, another experimental P-51D) by about 4.5 seconds and the lead airplane (*Strega*, also an experimental P-51D) by about 8.8 seconds. The accident airplane was traveling about 445 knots as it passed pylon 8 (see figure 1) and experienced a left roll upset

Figure 1. Diagram of the NCAR unlimited class race course at RTS, showing relative locations of pylons and the accident site.

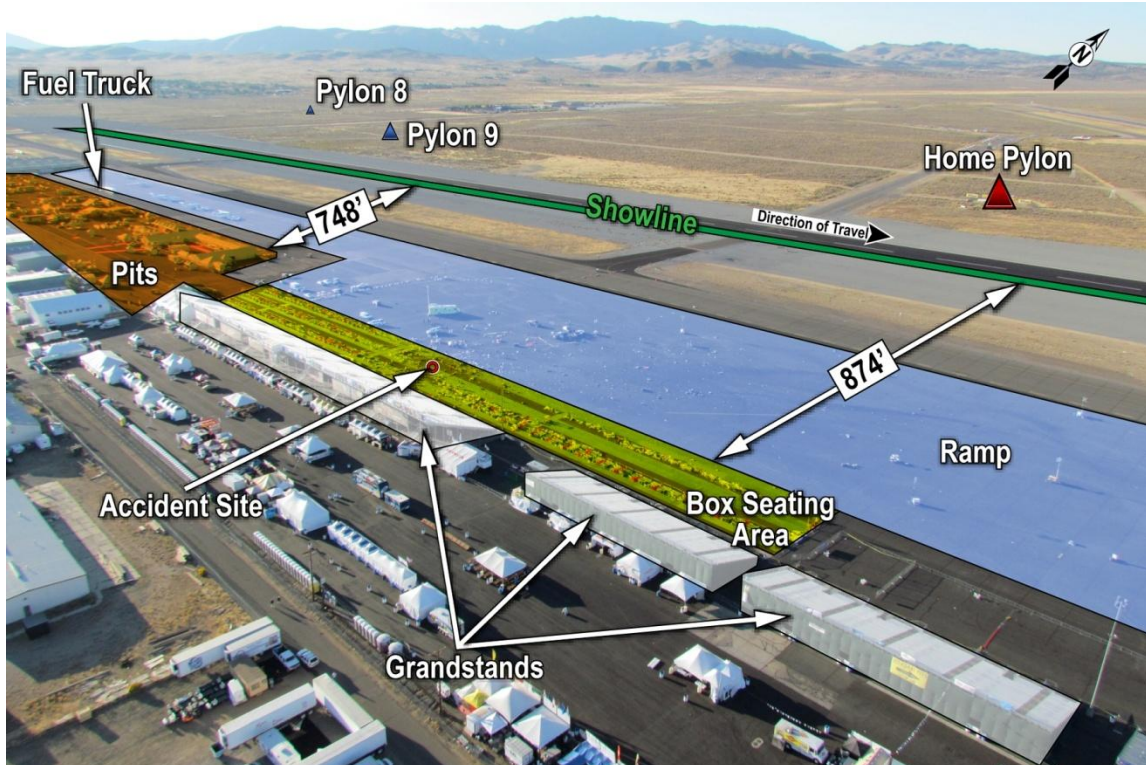
Ten people on the ground were fatally injured and dozens of others sustained minor to serious injuries when the airplane collided with the airport ramp in the spectator box seating area and scattered wreckage debris in the box seating area, ramp, and grandstands. The edge of the box seating area was 874 feet south of the showline, the edge of the pit area (where many other spectators were located) was 748 feet south of the showline, and a fuel truck was parked on the ramp near the pits (see figure 3). Racing airplanes were expected to fly parallel to the showline on the north side.

Figure 3. NCAR ramp area layout with accident site depicted.
