White Paper

Beechjet Landing Gear Down-lock Switches

Bob Nuckolls, Sr. Engineer/SME
Raytheon Aircraft Company
Phone 316-676-3286
Bob_Nuckolls@rac.ray.com
Revision –A- 11 February 2004
Revision –B- 13 February 2004
Revision –C- 12 March 2004

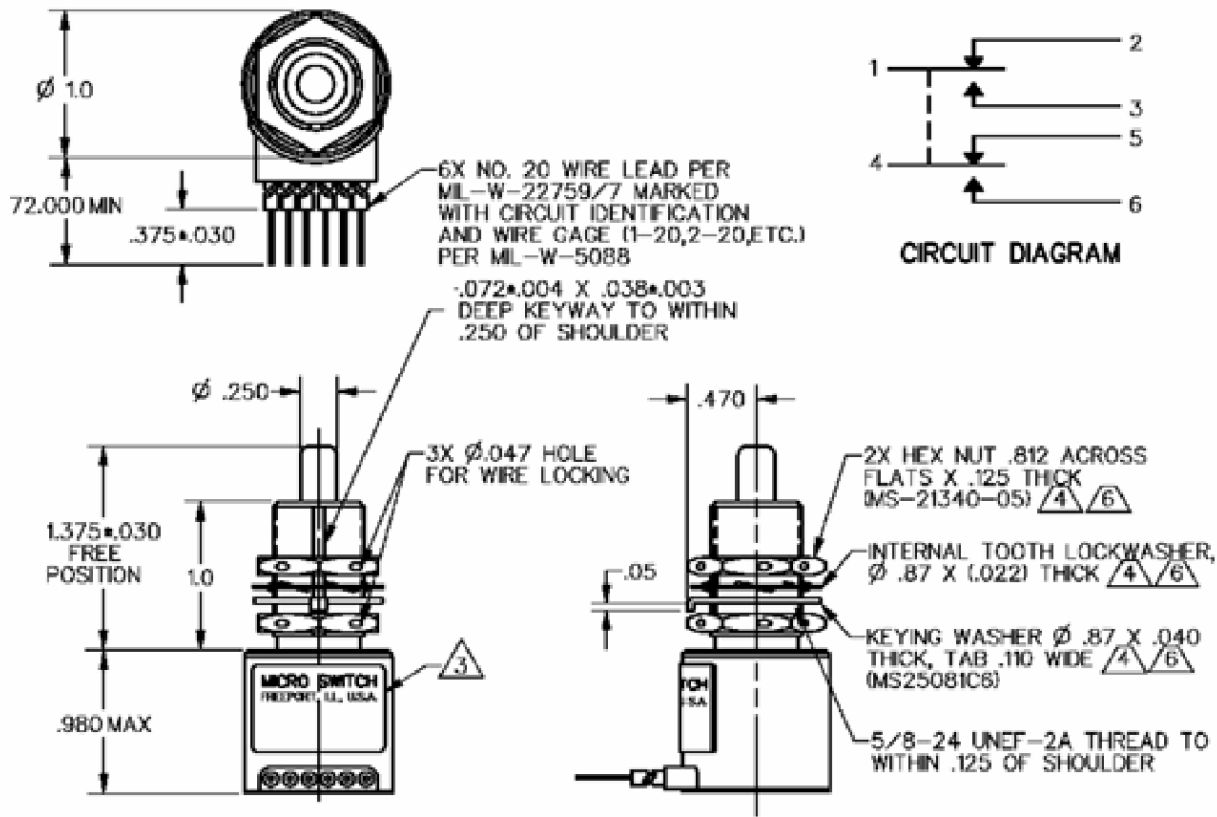
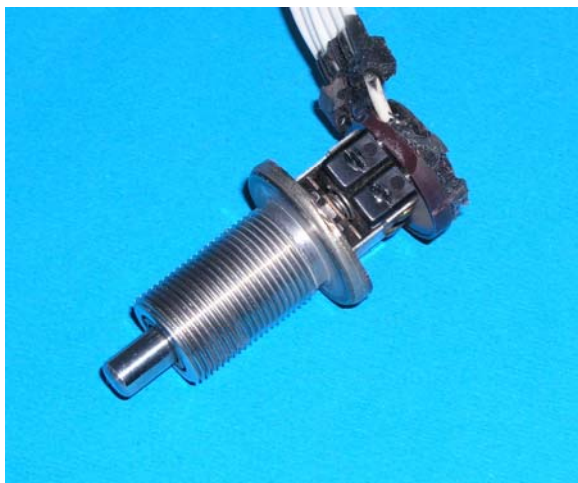
The drawing above illustrates basic dimensional and wiring details for the 1EN6-1 switch assembly.

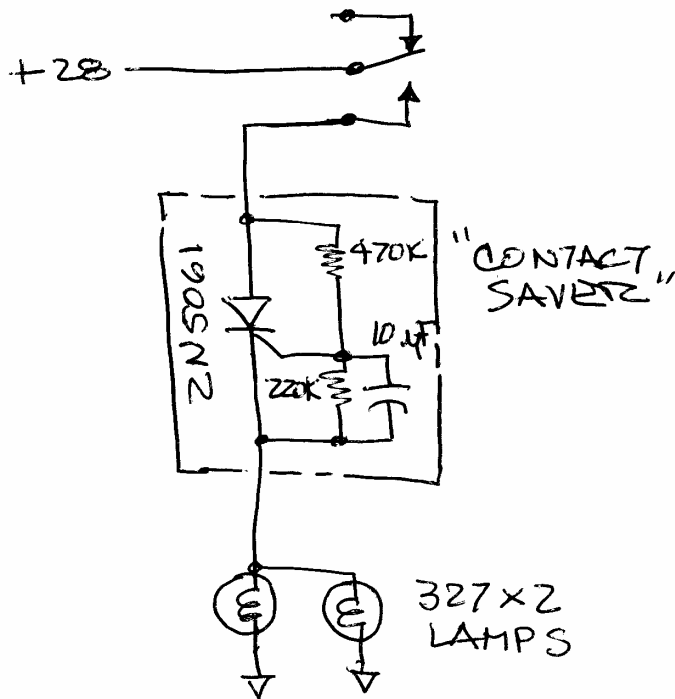
The failed contacts in all three switches drive two #327 lamps in parallel from a 28 volt bus. Inrush current for this lamp pair is on the order of 1.0 amps while the running current is only 0.08A total. Metal transfer observed is reminiscent of that

observed while investigating sticking contacts on small crystal can relays used to control roll trim motors on the Beechjet. Tests have shown that the capacitive nature of the roll trim motor (high quality RFI filter on actuator motor leads) provides a sharp-edged inrush current not unlike that of an incandescent lamp. Further, tendency of a relay to stick is related to how many times the contacts bounce when closing.

The loss of contact performance on the down-lock indicator switch contacts may be related to high inrush currents that flow during the contact bouncing interval. A current trace taken on a pair of #327 lamps shows that an inrush current of nearly 1.0 amps is decays to half that value in about 500 microseconds . . . same order of time that the 11SM370 switch contacts are bouncing.

Contact bounce offers approx. 8x increase in opportunity for the effects of inrush current to degrade contact performance.

Adding an electronically delayed onset of inrush currents has an obvious benefit with respect to wear rates on the relays; I'll suggest similar benefits can be realized by including a similar circuit on the landing gear indicator circuits.
