400EXXX

BEECHJET ROLL TRIM RELAY FAILURE ANALYSIS

RECOMMENDED CORRECTIVE ACTION

Date: August 18, 2004

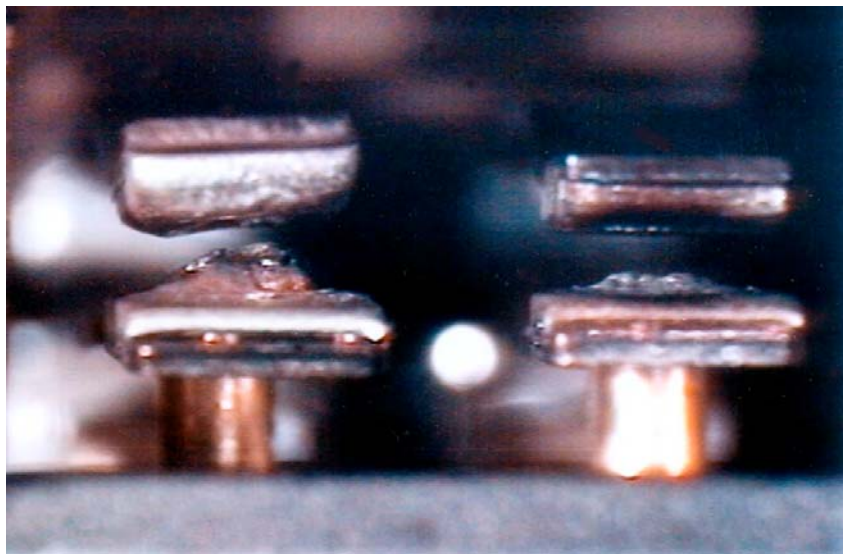
Relays used in this system are Mil-Spec, M83536/2-028M devices available from several suppliers. This report will describe an investigation, testing and development of a rational for giving preference to one supplier (Magnecraft-Struthers-Dunn) based upon a demonstrated robustness advantage compared to then current supplier (Deutsch). This report will further describe less frequent but significant sticking of the preferred relay and the investigation that ultimately identifies root cause and a proposed change to the system design to fix the problem. The troublesome relay is a “5-amp, crystal can” device that can be either socketed or soldered into the circuit. The original design inherited from Mitsubishi on the Diamond used soldered in, 10-amp relays. The relays were mounted in junction boxes on spacers and screws. At serial number RK-xx, the larger, soldered in relays were

replaced with the smaller relays mounted on plug-in modules. There is no recorded history of sticking of the larger relays.

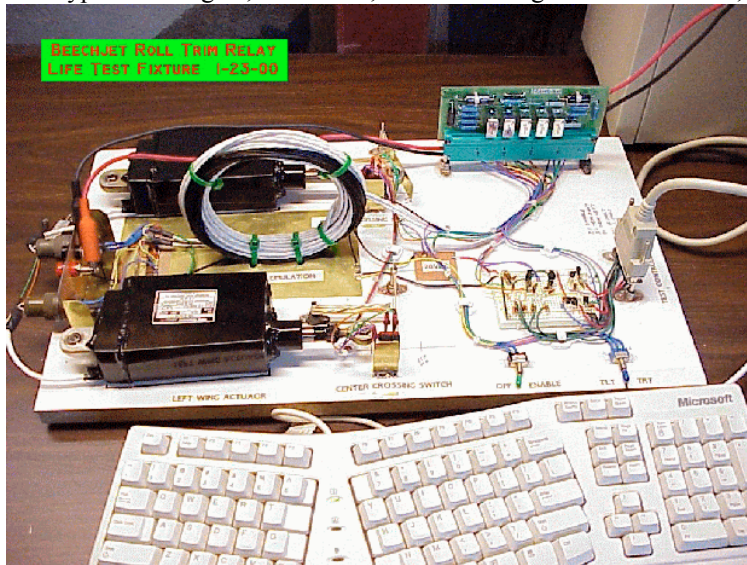
2.1 Roll Trim System Simulator

A bench test fixture was fabricated to emulate the roll trim system in the aircraft. The fixture included exemplar wire types and lengths, RFI filters, center crossing detector switches, and a socket for Roll Trim Control board to be tested.

An interface circuit provided a means for sending roll trim commands to the fixture from a supervisory computer. Fault monitoring circuits were included to halt the testing if a sticking of normally open contacts is detected.

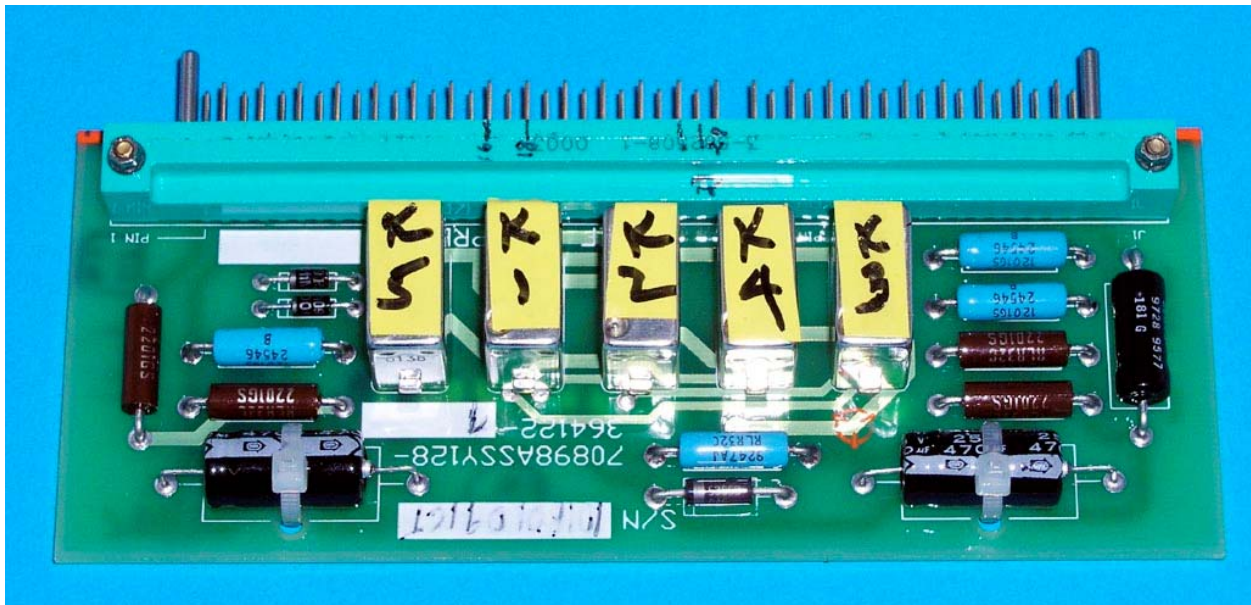
A total of 4 roll trim boards were tested on the system simulator described above. One board was a field return populated with Deutch relays. This board duplicated the sticking phenomenon in a few cycles (less than 200). Two new boards populated with Deutch relays were tested. Both boards began to show the sticking phenomenon in 27-40 thousand cycles. A new board was populated with MSD relays. This board ran

480 thousand cycles with no sticking.

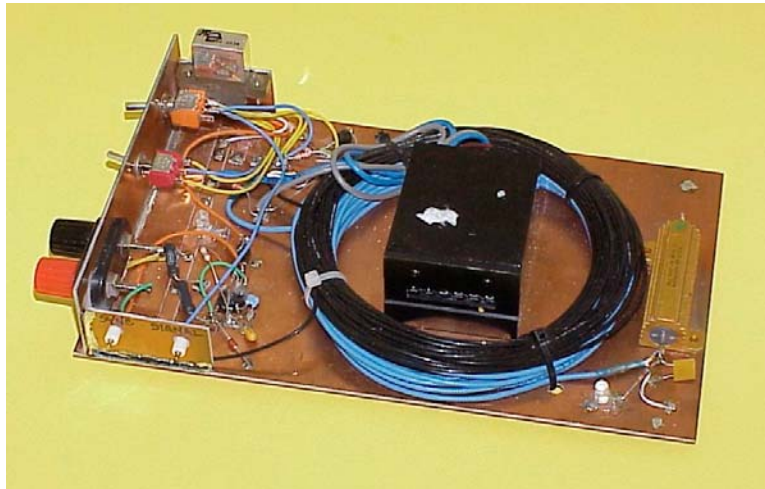
shielded motor feed wiring.

A "mini" fixture illustrated here (Schematic Appendix A, Figure A1) was crafted to . . .

- Cycle the relay under test at approximately 6 cycles per second.
- Replace the motor/actuator load with the equivalent resistive current load.
- Simulate the sum total of ship's wiring in the motor power path consisting of 30 feet of 20AWG power feed wire and 30 feet of

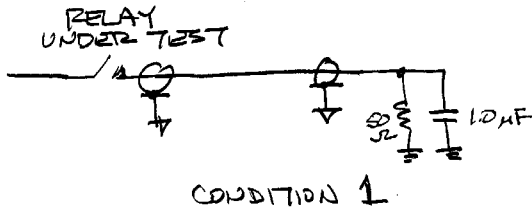
Condition 1. The first test condition is described in this sketch where all components emulating the aircraft configuration are in place: The first test article ran for 500K cycles on the section A contacts without sticking but metal transfer was spectacular.

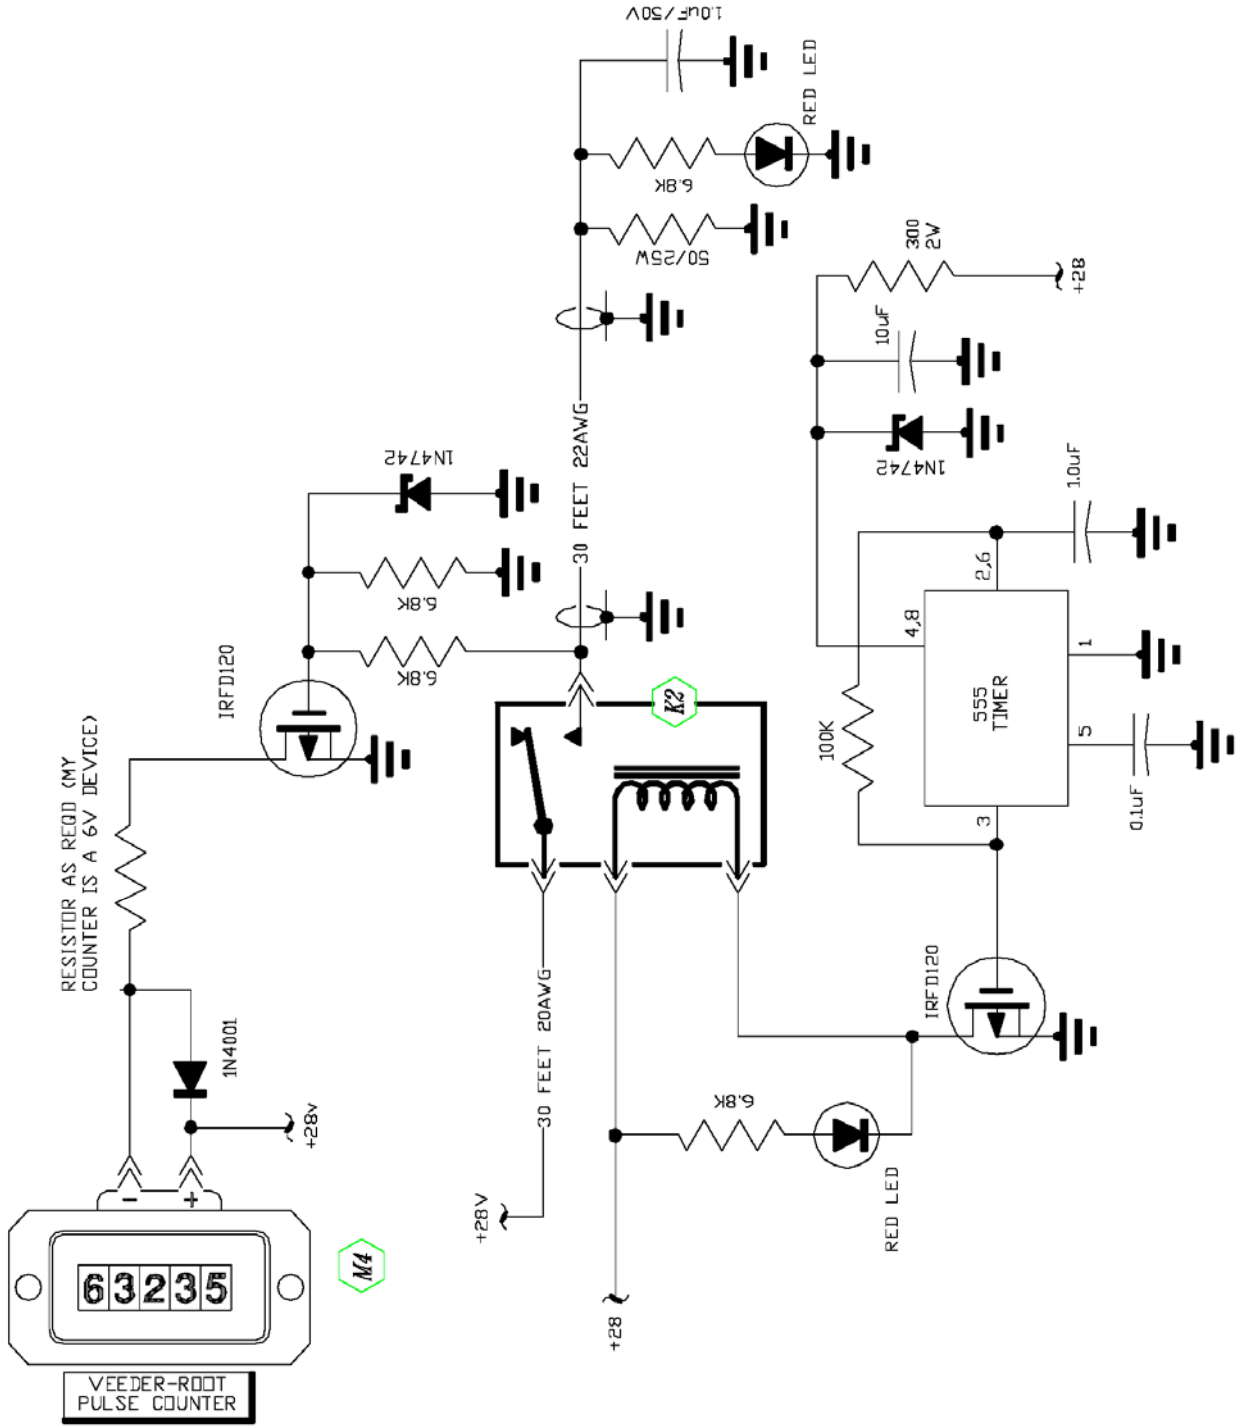
Figure A1	Schematic of Component Level Test Fixture
Figure A2	DO-160 Conducted Emissions Data for Roll Trim Acuator

EUT: 400A ROLL TRIM ACTUATOR
Manufacturer: SMITH
Operating Condition: No filter
Test Site: RAC
Operator: DON PHELPS
Test Specification: DO-160D (Informal Engineering Test)
Comment:
