Why you Should Know your ECU; Three Case Studies

Why you should know your ECU; Three case studies.

CASE STUDY ONE

CASE STUDY TWO

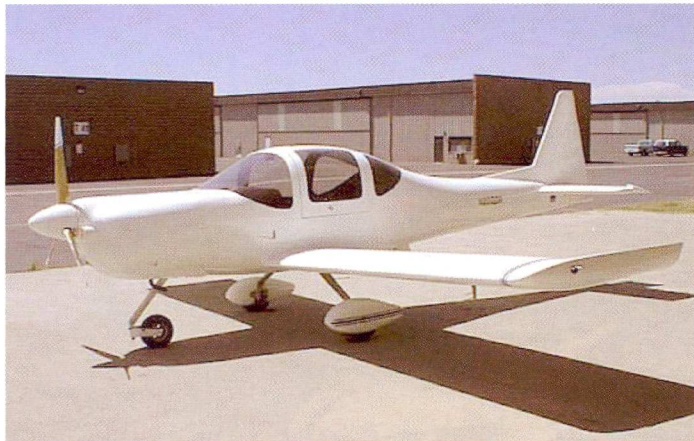
All indications are that the OEM ECU sensed some condition that it was programmed to believe was catastrophic for the engine and shut it down to "limp home" mode. In an automobile, this is a very handy feature since it allows you to limp home at 20-25 MPH so you can get it fixed, but not so good for an airplane.

It appeared that when the engine was run at full throttle for some predetermined length of time (in my case it appeared to be about a minute at about 4,600 RPM), the ECU reduced the power down to about 2,200. Probably the reason it didn't happen during the first flight was I was only using partial throttle. The previous occurrence of limp home (in Michigan) happened at altitude after the pilot completed his climb and started a high speed test run (see case study 1 for details).
